REVISTA DE GEOCIÊNCIAS DO NORDESTE

v. 6, nº 2 (2020)

GEOMORPHOLOGICAL FACTORS IN THE CONTRIBUTION OF THE OCCURRENCE OF EROSION PROCESSES AS ROADS OF THE TO-445 ROAD, MUNICIPALITY OF MIRACEMA-TO

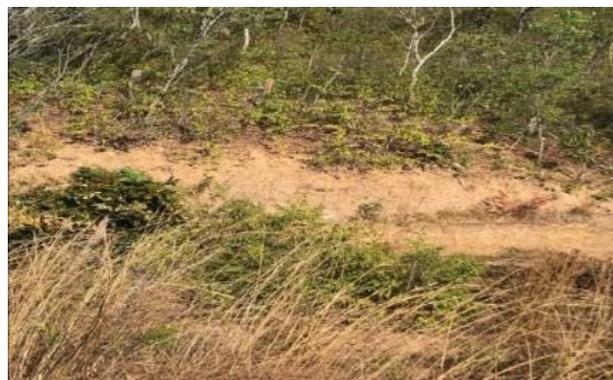
Figure 2- Dry vegetation on the margins of the TO-445 road, with a possible preferred path at point P05. Source: author (2018).

The first visit to the study area took place in a dry period, held in August 2018. Through this, it was possible to observe dry vegetation, mainly due to the period of greatest absence of precipitation, facilitating possible surface runoff (Figure 2).

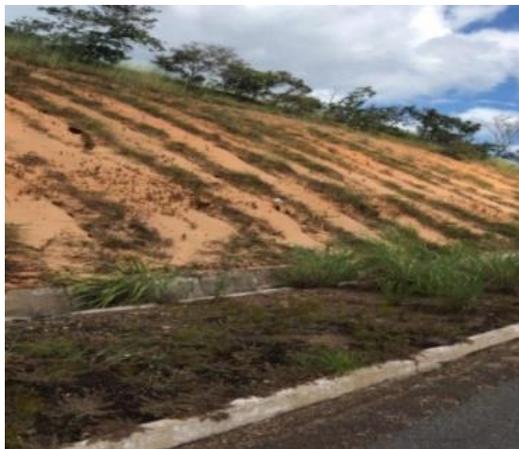
Figure 5 - Laminar erosion on a slope at point P10 along the TO-445 road. Source: author (2019).

The erosions shown in Figures 5 demonstrate the concern in the study of the area in question, since they can lead to the destabilization of the highway, promoting its partial or total destruction in the next years, if there is no type of maintenance.
