REVISTA DE GEOCIÊNCIAS DO NORDESTE

v. 9, nº 1 (2023)

Application of the Betonbloc system, as an alternative to contain coastal erosion in the municipality of Ipojuca/PE

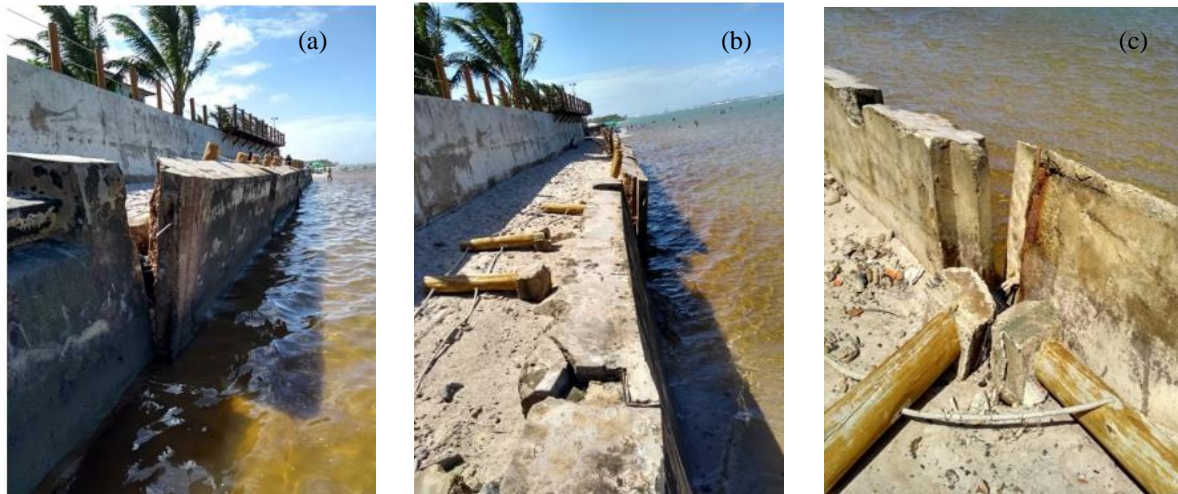
Figure 4 – (a,b,c) situation of the existing maritime retaining wall, Ipojuca/PE.
Source: Authors (2023).

The study area has a plot of approximately 6,160.93m², where is located a high-standard residential condominium, built since 2005 by the sea of Muro Alto, and with an extension of 120m facing the coastline. The study area had a self-sinking sea wall, where the existing infrastructure was in a very poor state of conservation, offering high risk of collapse and danger to the population.. The existing wall has been degraded due to the advance of the sea and the erosion caused by the vortex of the waves, as shown in Figure 4. The outflow of sand from the abrasion platform has contributed to the collapse of this infrastructure.

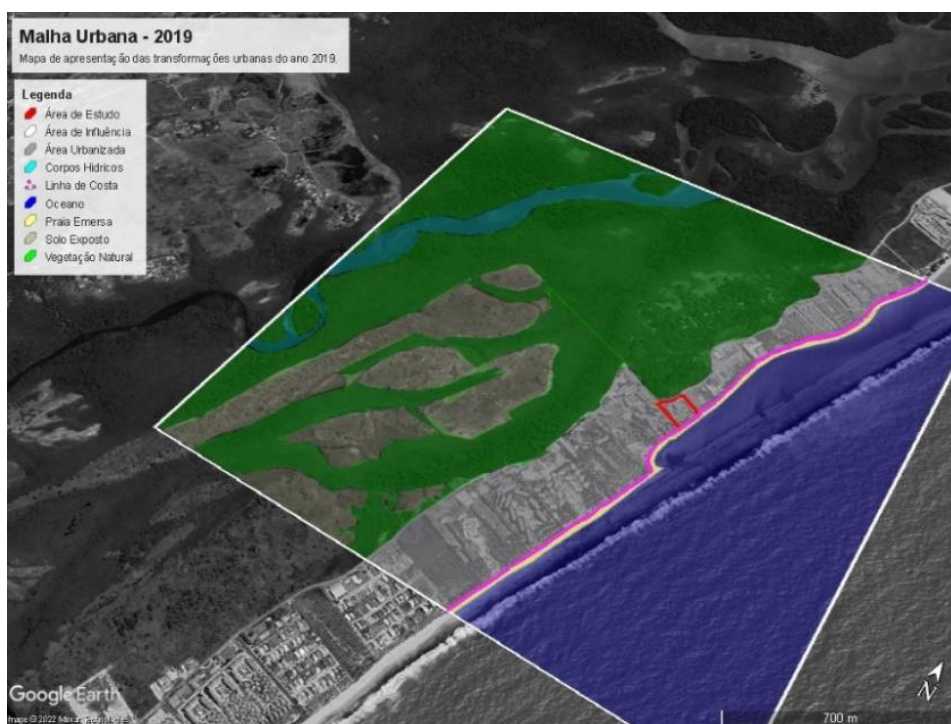
Figure 7 – Urban transformations of the year 2019

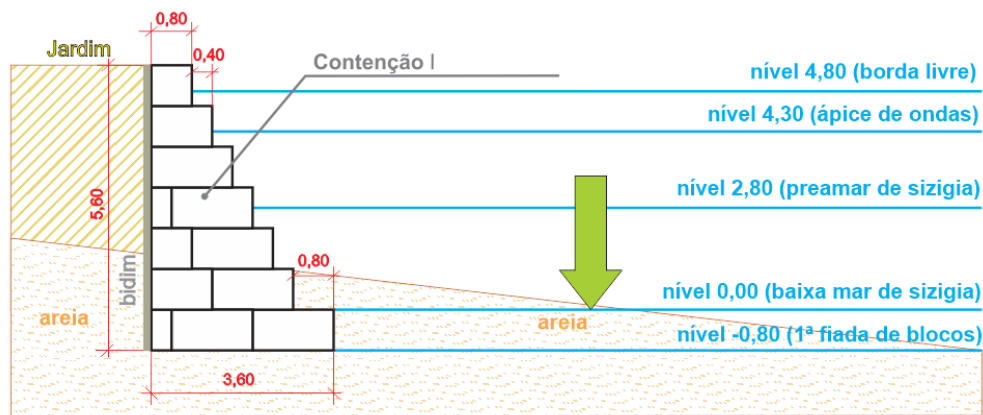
Figure 8 – Transverse profile of the maritime retaining wall in BetonBloc, Ipojuca/PE.

The retaining wall in BetonBloc was designed with a foundation built below sea level 0.00 m. This characteristic has the function of preventing transversal sediment transport under the wall foundation, thus avoiding the destabilization of the retaining wall (Figure 8).

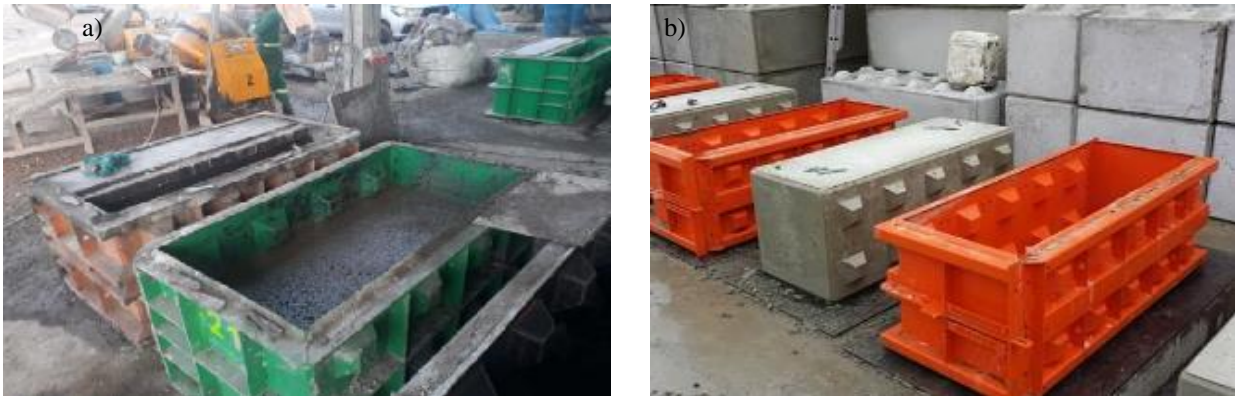
*Figure 11 – Modeling and concreting of blocks a) concreting b) the concrete block
Source: Authors (2019).*

In the manufacturing process of the blocks, metallic molds were used, reinforced on top of metallic plates. The concrete was poured directly into the mold, where there were no traces of wood, bags, sand and any other input in the manufacturing process, ensuring the homogeneity of the concrete, figure 11. After 3 days of concreting the blocks were unformed and stored in the shed. Only the blocks that would be used on the day of assembly were transported to the construction site. In the manufacturing process of the blocks, metallic molds were used, which were assembled on top of metallic plates.

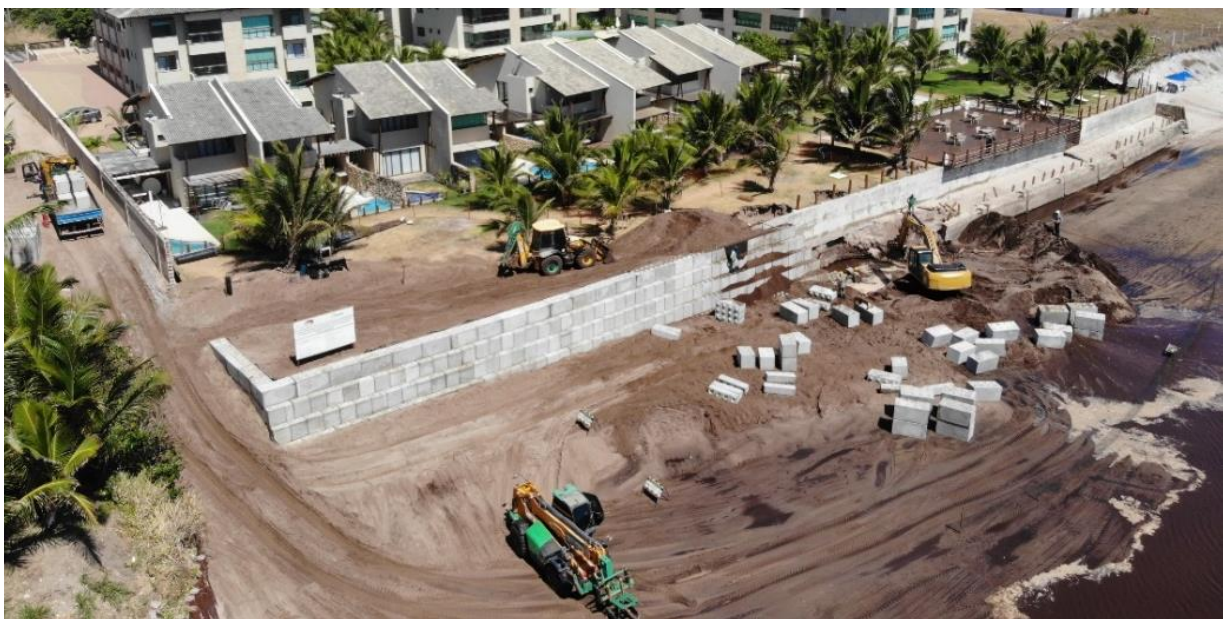
*Figure 12 – Maritime containment execution / Ipojuca -PE
Source: Authors (2019).*

Figure 12 shows the implementation of maritime containment already at the completion stage of the work.

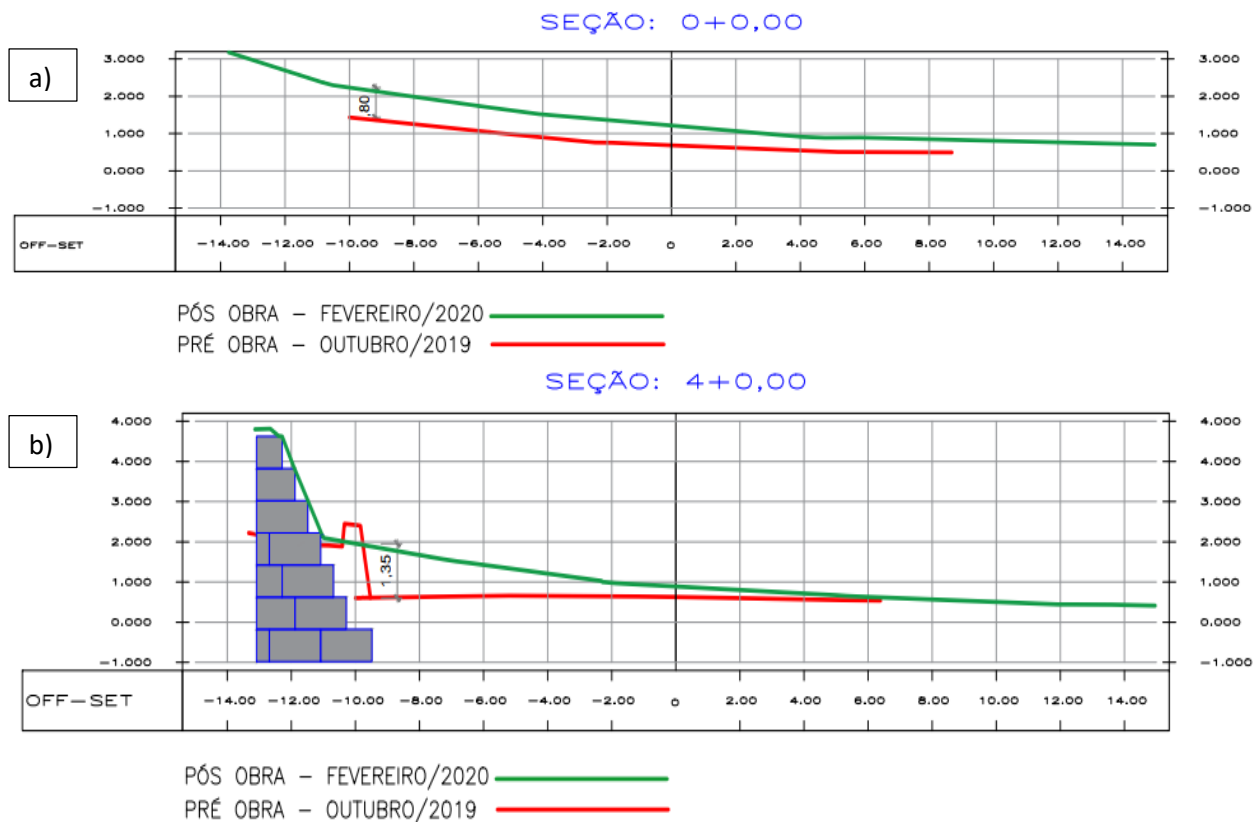
Figure 13 – Comparison of topographic levels of maritime containment: a) pre-work – October/2019; b) after work - February/2020
Source: Authors (2020).

In the monitoring of the post-construction beach profile, the first measurement was carried out in February/2020, after 30 days of completion of the work, where it was called "Post Work - February/2020" which was the beginning of monitoring the beach profile of the following 12 months. In the measurement "Pre Work - October/2019" and "Post Work - February/2020", there was a gain of 80 cm of sand height in section 0+0.00 (Figure 13-a). The section 4+0.00 was the one that stood out with an increase of 1.35 m of sand height, indicated in Figure 13-b.
