REVISTA DE GEOCIÊNCIAS DO NORDESTE

v. 10, n° 1 (2024)

Morphodynamics analysis of the Natural Monument of the Cliffs of Morro Branco, Ceará, Brazil

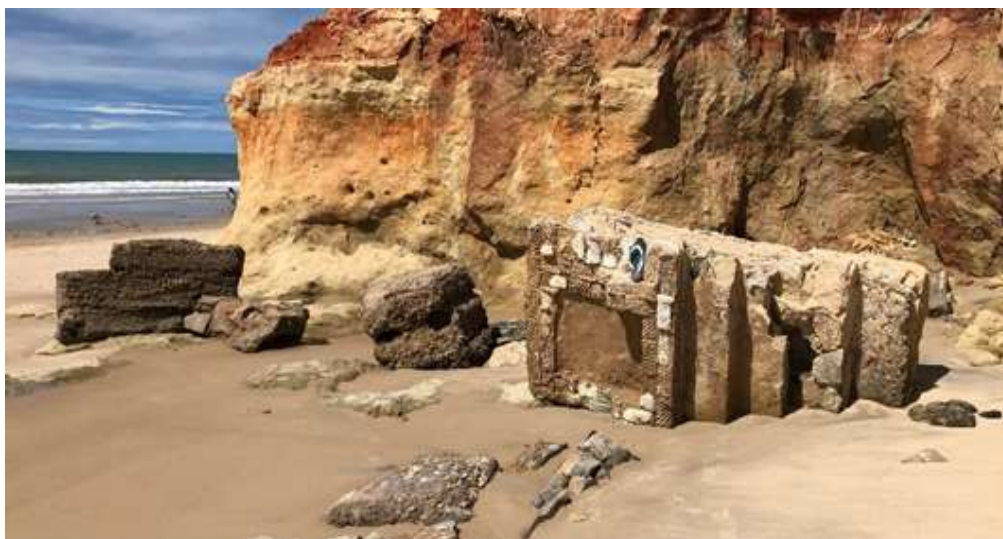
*Figure 5 – Debris from summer residences located on the Morro Branco beach strip.
Source: Prepared by the authors.*

This risk of mass movement on the beach, beyond the cliffs, is heightened by debris from destroyed homes in irregular areas, or from the retaining walls that protect summer houses still on site (Figure 5), which in turn, completely distort the rock structures evident on the beach. In addition to the evidence under analysis that points to the risk of accidents similar to what occurred in Pipa, located in the municipality of Tibau do Sul, in the State of Rio Grande do Norte, there was a mass movement event that resulted in the death of three tourists, a couple and a child, who were close to the beach cliffs looking for shade, when the material that hit them was displaced (ZAULI *et al.*, 2020).

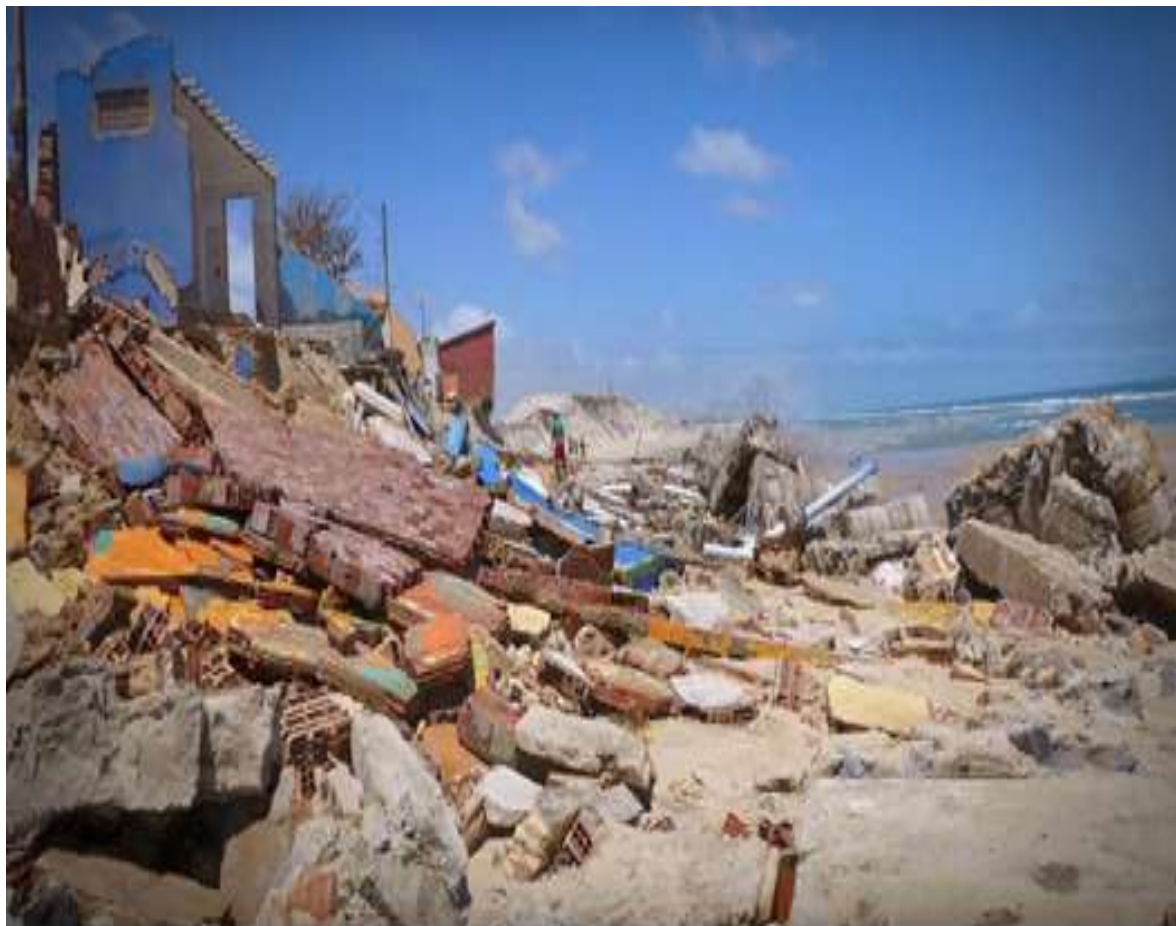
*Figure 7 – Debris at the seaside of commercial structures on Morro Branco beach destroyed by the sea.
Source: Eduard Sweets, 2016.*

It is important to highlight that physical structures such as tents, kiosks and other buildings have already been destroyed previously (AMARAL, 2020). The damage is not exclusively environmental or financial for those who own these fixed assets, but also to the scenic potential of the beach after the events of destruction of the fixed assets (Figure 7) – in addition, obviously, to posing a risk to those trying to save the fixed assets. their assets amid oceanographic events.

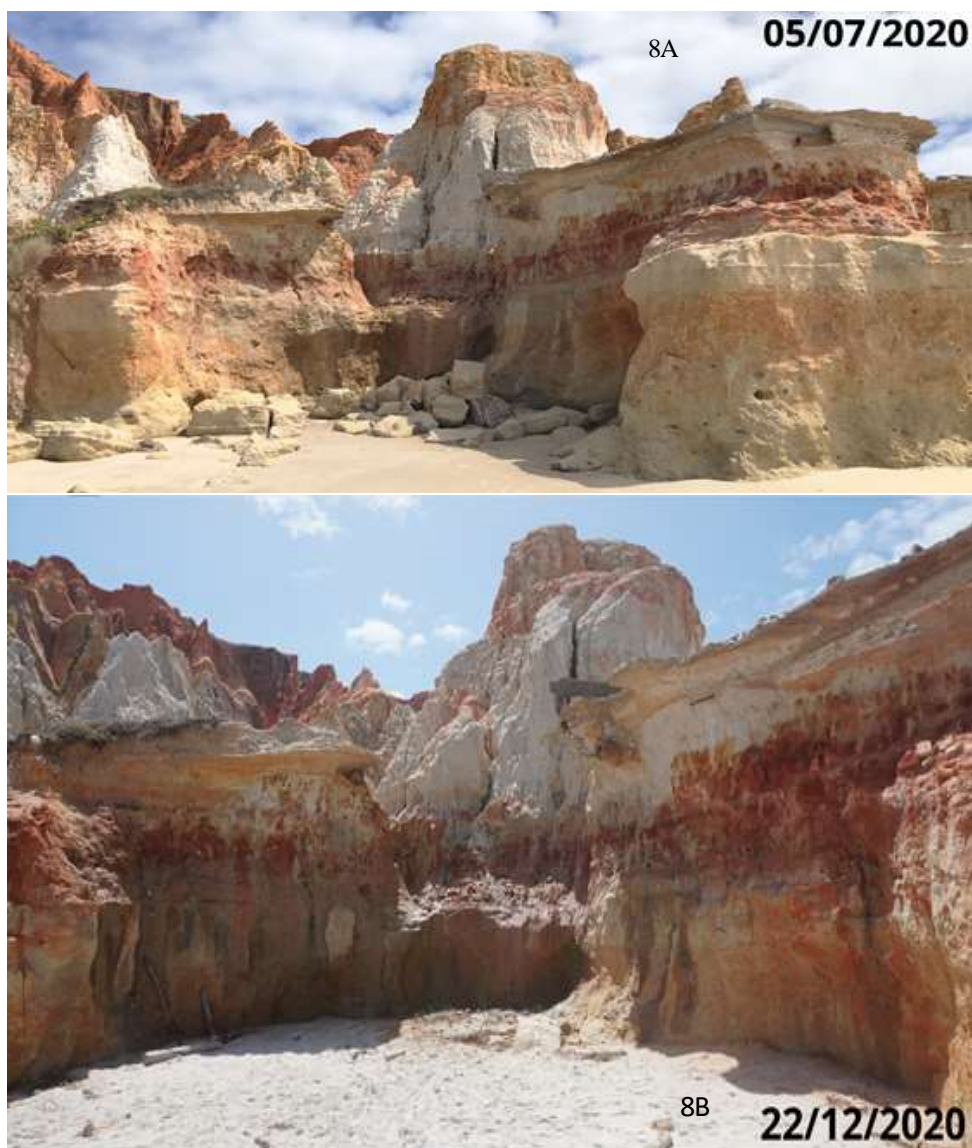
*Figure (8) (a) and (b) – Sample of the removal of coarse material provided by the mass movement.
Source: Prepared by the authors.*

The intense maritime phenomena, which bring about changes in the area under study, led to the choice of fixed points for a qualitative analysis, contemplating the change in a landscape over a period of five months. Figure 8 shows one of the samples of the erosive capacity of wave undermining against the rigid structure of the base of the cliffs. This significant change occurs in this short period, and it becomes questionable how long the summer resorts located under the cliffs can remain. Following the retreat step by step, in specific spaces, daily used by tourists and local residents, highlights in more depth the risks that disorderly interventions can cause.

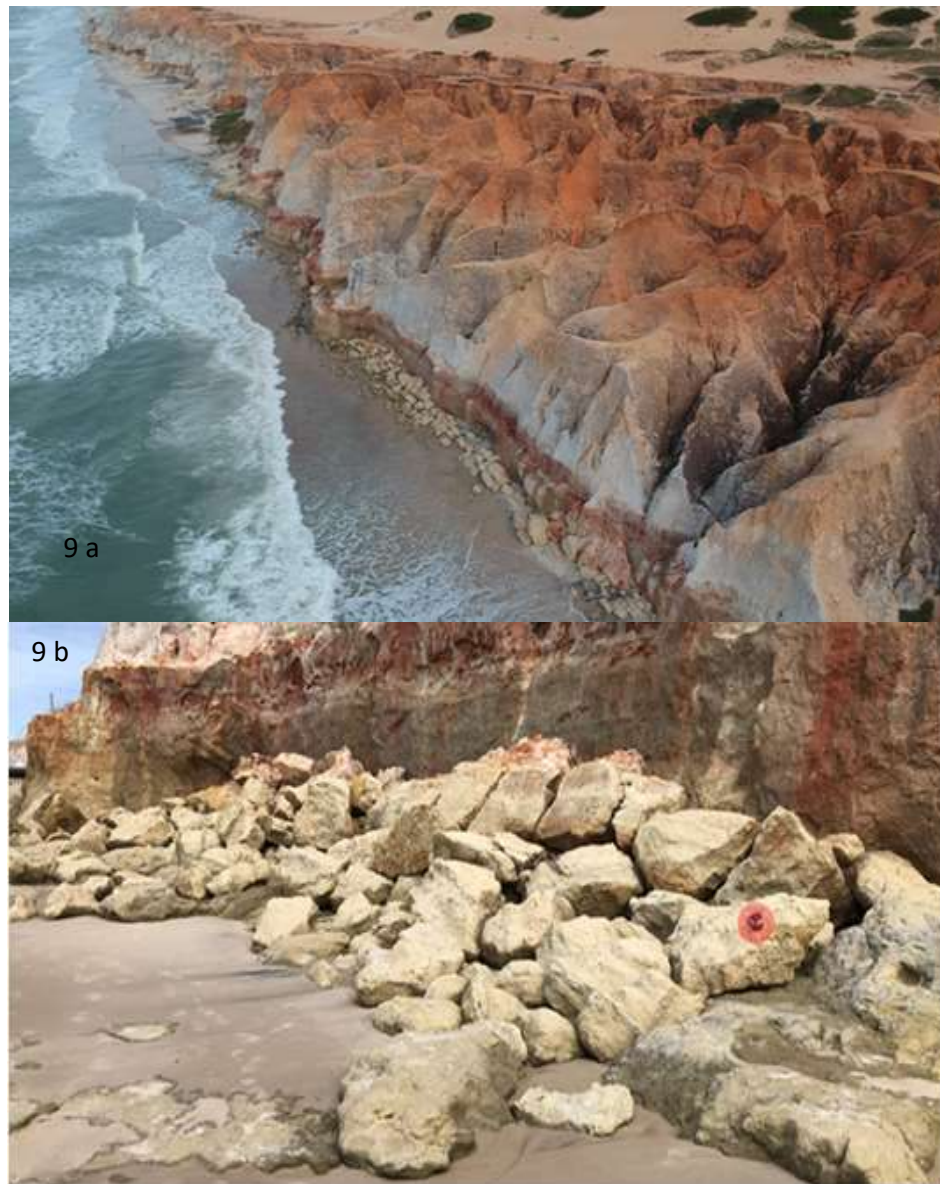
*Figure 9 (a) and (b) – Structure of the cliffs and the rocky material resulting from the mass movement deposited at the base being compared with a 20 cm object.
Source: Prepared by the authors.*

This dynamic does not occur punctually in the samples in evidence, but along the entire chain of cliffs that overlook the Natural Monument, several rocks that exceed one meter in diameter spread along the coast after intense maritime events that intensify the undermining of waves in the structure of the cliffs (Figure 9). No signage or guidance was found throughout these structures regarding the risk of mass movement. However, as previously shown in Figure 5, it is not difficult to find street vendors close to the cliff wall with water spouts nearby, or tourists behind a shade.

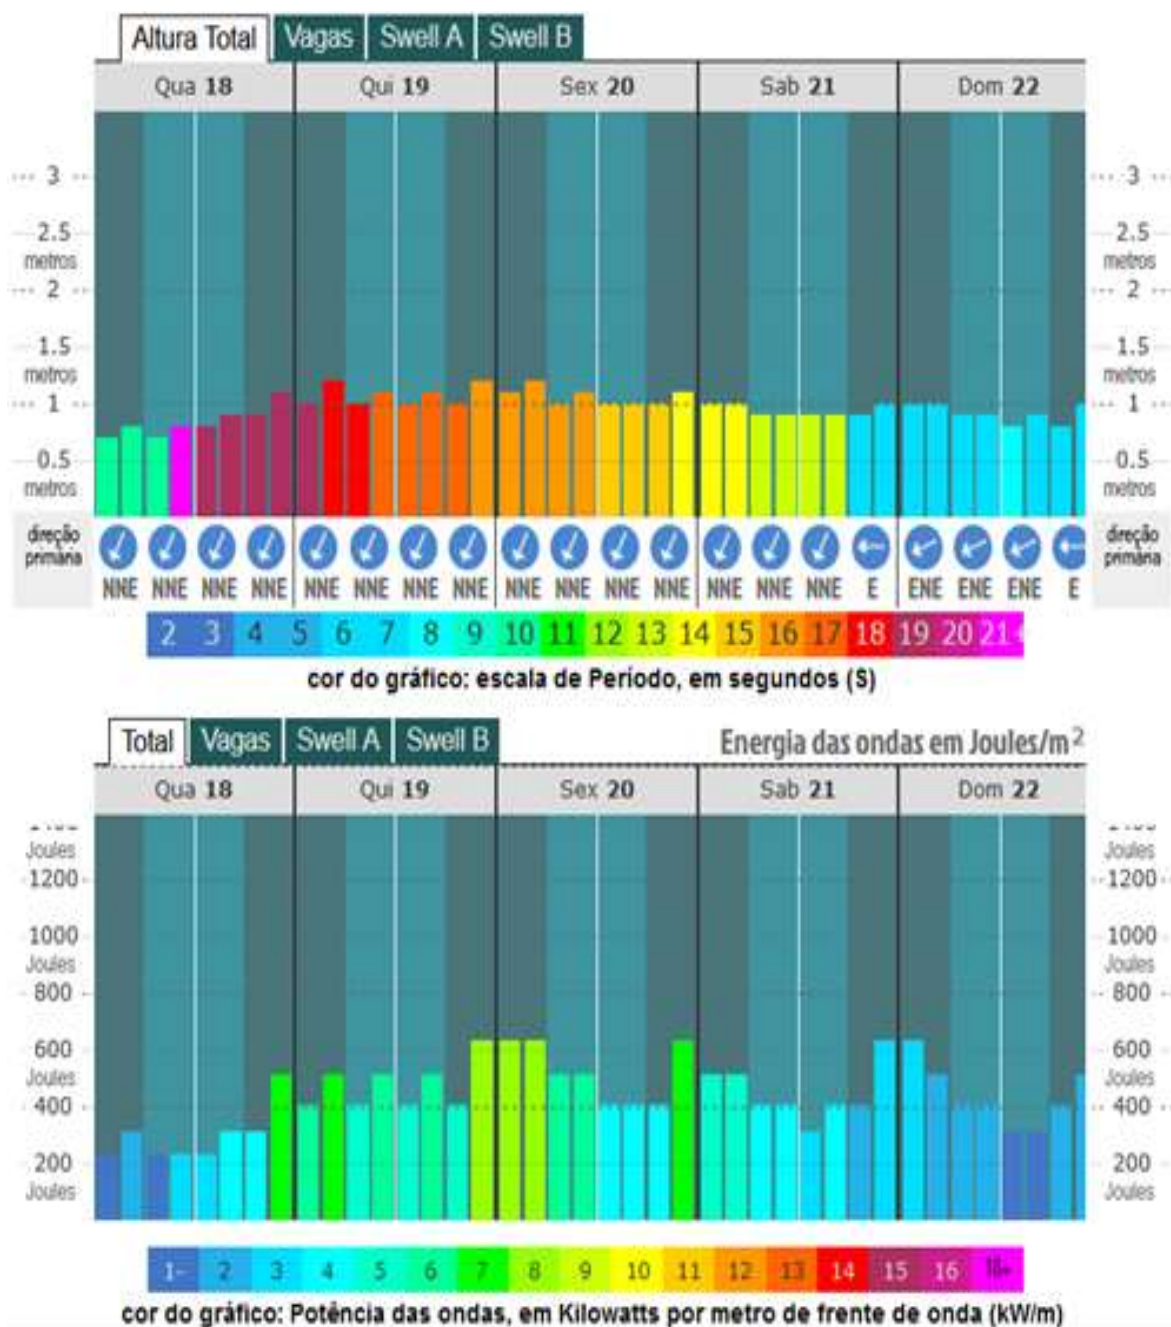
Figure 10 – Sample of one of the most significant events of 2019 on the coast of Morro Branco. Source: adapted from Surf guru (2020).

In figure 10, the period (in seconds) reaches the most intense values provided by the scale (+21), despite having a wave height of around one meter. The predominance of the waves occurs in the N-NE direction and exceeds values of 600 joules, quantifying the intensity of the mechanical force of wave undermining and justifying the mass movements recorded throughout the field visits. The highlighted sample from the year 2020 presents similar, but more intense, characteristics, highlighted in figure 11.

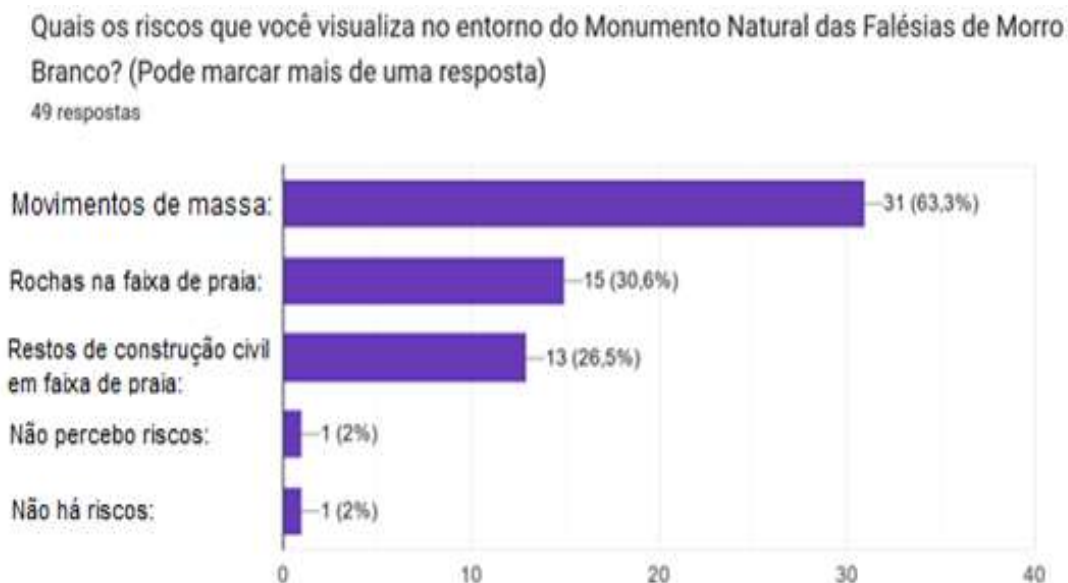
Figure 13 – The perception of Bugueiros and tourism informants about the risks on the cliffs of Morro Branco. Source: Prepared by the authors.

The 58 volunteers participating in the research indicated that the main risk existing along the Falésias Natural Monument is Mass Movement (66.7%), both on the beach and within the conservation unit. Other points raised were the rocks of the cliffs and remains of buildings resulting from the destruction of walls of summer houses, where each of these points was considered a risk by 26.2% of the participants.

In an open response, only 2.4% of volunteers indicated that they did not perceive any risk in relation to UC. Mass movements do not occur exclusively in the region of the cliffs, but they also suffer intense erosive processes caused by precipitation and wind action – included even in the comments in graph 3. In this sense, throughout the “Labirinto das Falésias” region, a space where the city's main tourist tour takes place and that there are several places of instability due to mass movements, so that the main routes used were specialized in Figure 14.

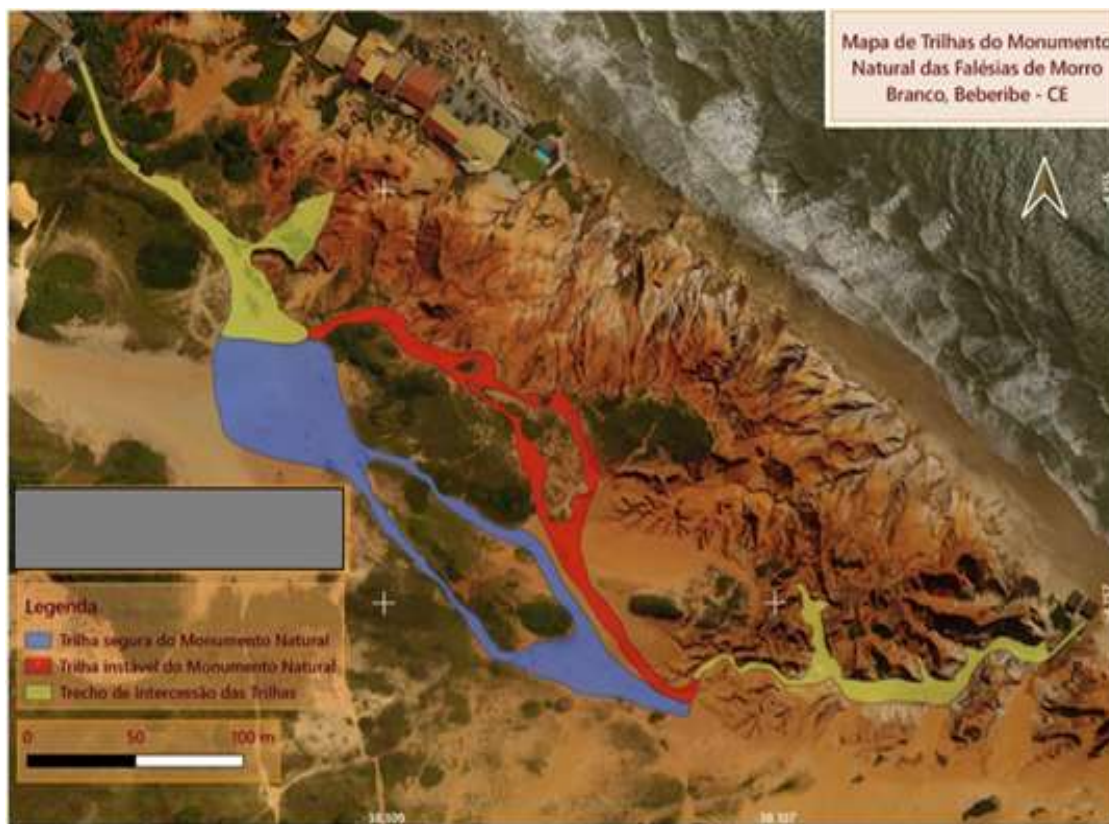
Figure 14 – Map of trails of the Morro Branco Cliffs Natural Monument.
Source: Prepared by the authors.

The mapping in Figure 14 indicates two large groups of trails, both of which present alternative path options, used by tourists and tour guides at the Falésias Natural Monument. One of the trails is directed more inland, expressed on the map by blue spaces, which is located closer to the fixed dune fields, in order to contemplate the landscape generated by vegetation in rainy seasons and the lighthouse. The other route, the section characterized by the reddish color, commonly used by smaller groups, is closer to the topographic irregularities with narrower and more unstable spaces, where the scenic potential of this section is highlighted by the features of the “Labyrinth of the Cliffs”, through a Topographically privileged view that also includes the coast of Morro Branco.

The yellow region shown on the map corresponds to the intersection areas between the two main alternatives, which include movements along the entrance and exit of the walk along the Natural Monument. It is also important to point out that there are other sections and trails that are explored by tourists, such as the Farol Trail and other sections, however, only those routes that are most used by visitors were analyzed here.

Mass movements put at risk passages constantly used by tourists and guides (figure 14, red color), so that the traffic space in some locations becomes recurrently reduced, as in Figure 16. It is worth highlighting that in none of these routes are there any signaling about the risk of mass movements, or the like. Furthermore, on many occasions visitors are accompanied by tourism informants from the municipality, especially when this activity takes place in small groups, as seen in Figure 15.

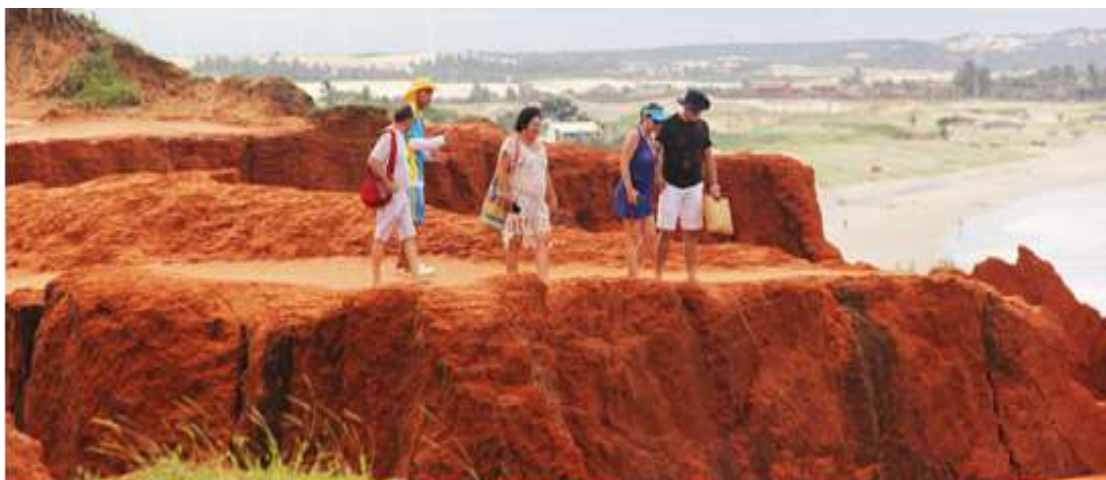
*Figure 15 – Tourists in risk areas of the UC.
Source: Prepared by the authors.*

Along with the rainfall regime, the route taken by tourists also contributes to intensifying the erosion process and generating mass movements, through the compaction of exposed soil, especially in sections of high slope areas, to take photos, or contemplate the height of the “abyss” (Figure 15). Sometimes, the width of these “corridors” does not exceed 1 meter, meaning there is little space to cover. Furthermore, strong winds can cause imbalances in those traveling through this area. It is important to point out that the period of greatest rainfall intensity is also related to the high tourism season, which contributes to a greater intensity of the risk of mass movements.

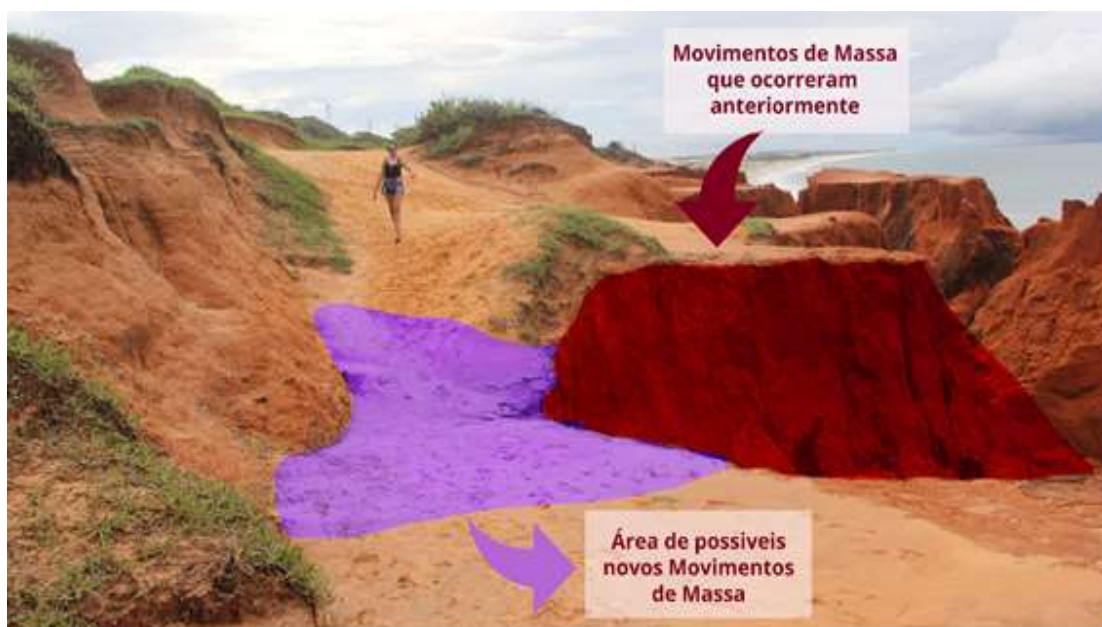
*Figure 16 – Sample of a narrow passage area, sometimes used by tourists, or natives, close to areas of mass movement.
Source: Prepared by the authors.*

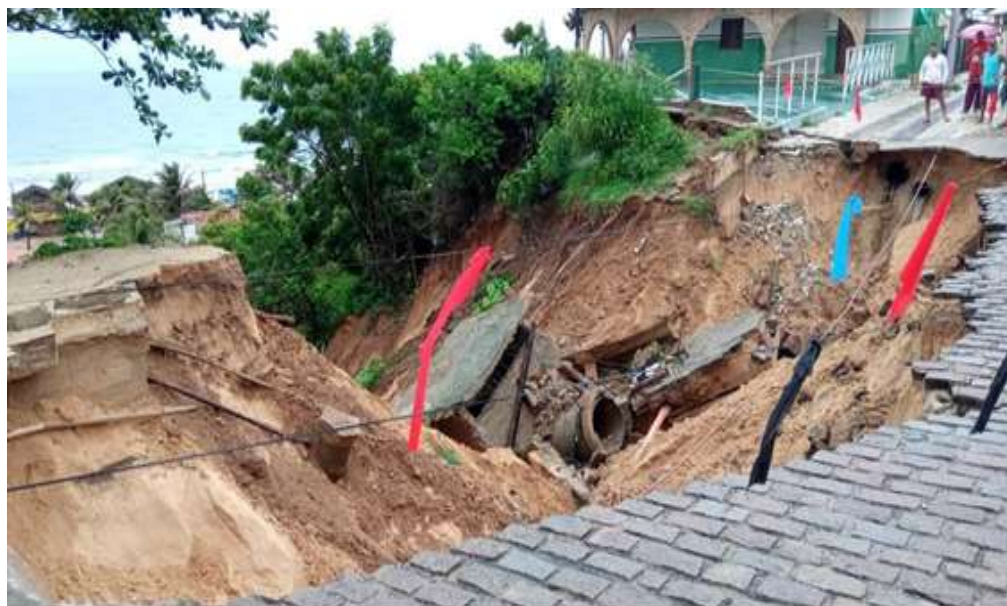
*Figure 17 – Mass movement at the Morro Branco Craft Center
Source: G1 Ceará, 2021.*

It is important to highlight that the rainfall regime is responsible not only for several mass movements in the Falésias Natural Monument, but also for the erosion process of the structures where a considerable part of Morro Branco's fixed assets are located. At the beginning of 2021, rainfall of 127mm, in a single day, led to the opening of a gully at the main tourist reception point: the Municipal Crafts Center (Figure 17). After this event, it was necessary to isolate the area, in addition to the evacuation of residents of residences close to the accident site.

These constructions are placed on top of structures similar to the Falésias Natural Monument, which are constantly visited. In fact, the collapse of Figure 17 included an area that was used as a parking lot for tourist buses. This sampling highlights the erosive power of the rainfall regime, not only in mass movements in the UC, but in the real and intense possibility of mass movements in strategic regions of different locations in the district. Through the above, the debate on mass movements in Morro Branco is not restricted to an environmental sphere, or to exclusive limitations of the Natural Monument; Nor should the erosive effects of these areas be limited to oceanographic issues, but this event points to the need to consider the alarming consequences of the intense rainfall regime in a short period, as presented in Table 3 combined with the local landscapes as evidenced in figure 16, together with the testimonies of local tourism agents (figure 13).
