REVISTA DE GEOCIÊNCIAS DO NORDESTE

v. 10, nº 2 (2024)

Environmental Quality of springs in a rural area, in the municipality of Pedra do Indaiá – MG

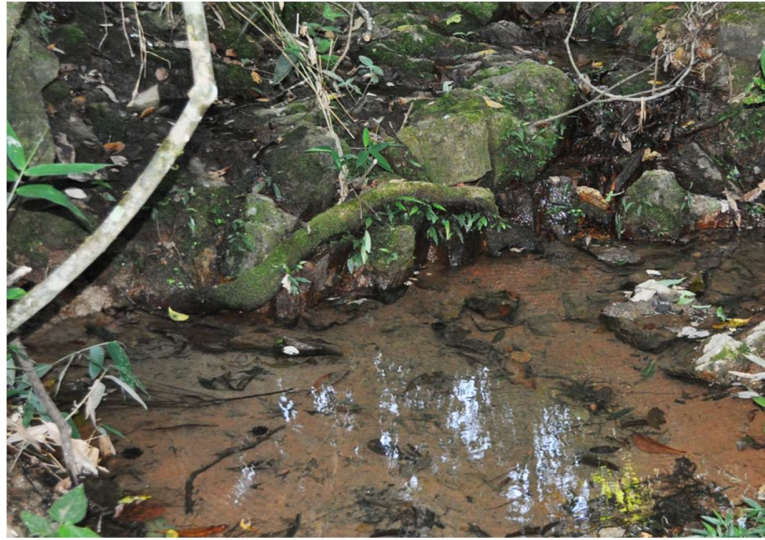
The macroscopic analysis of environmental impacts (Chart 2) showed that the color of the water was "transparent" in only two watersheds, springs 2 and 5, and "clear" in the other springs (Figures 2 and 3). According to Rocha et al. (2017), in preserved springs, a transparent coloration of the water is to be expected, which is considered a positive aesthetic parameter, since according to Botelho et al. (2001) and Ricklefs (2010), it favors light passage and the consequent photosynthesis of the existing aquatic vegetation. According to Souza (2004), light or even dark coloration can naturally occur due to rock or clay particles, the presence of added chemical elements or the decomposition of organic matter. It should be emphasized that natural erosion and/or erosion caused by anthropogenic actions can also cause changes in the color of water, and the revolving of the site by domestic animals or even wild animals cannot be ruled out.

*Figure 2 – Transparent water color in the spring 5
Source: Prepared by authors (2022).*

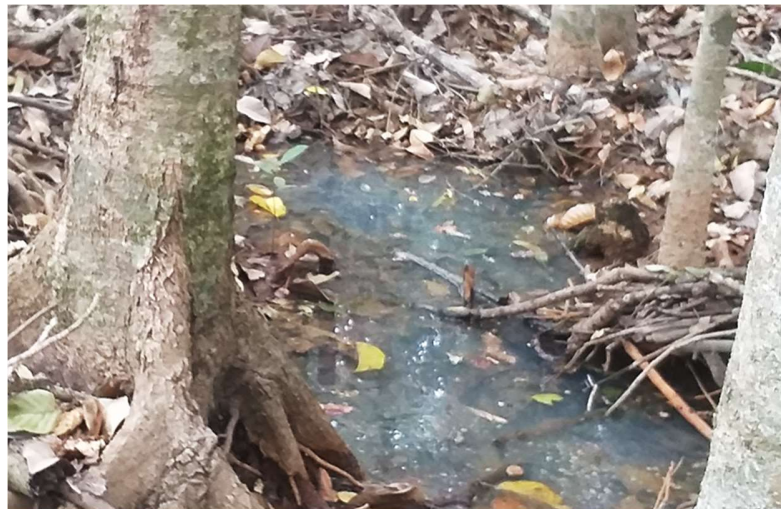
*Figure 3 – Color of the water, dark, in spring 3.
Source: Prepared by authors (2022).*

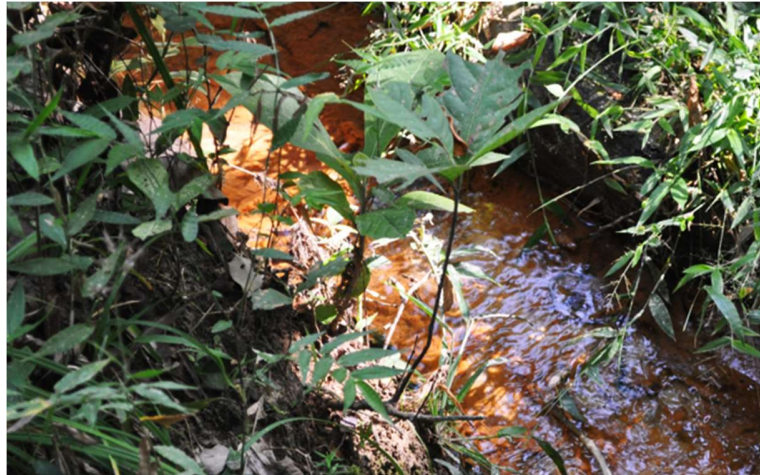
It is important to note that although the water was clear and even transparent, the presence of water or a bottom with a ferruginous color was found in eight of the assessed springs (Figures 4 and 5). This change occurs due to geological formation and also anthropogenic actions, which can favor excess iron ions in the water and enable the development of ferruginous bacteria (CARMO, 2016).

*Figure 4 – Ferruginous water from spring 10.
Source: Prepared by authors (2022).*

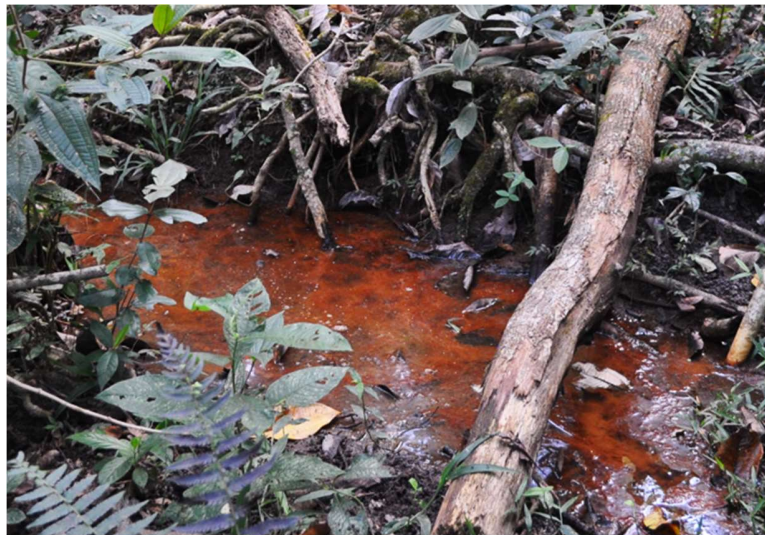
*Figure 5 – Ferruginous water from spring 13.
Source: Prepared by authors (2022).*

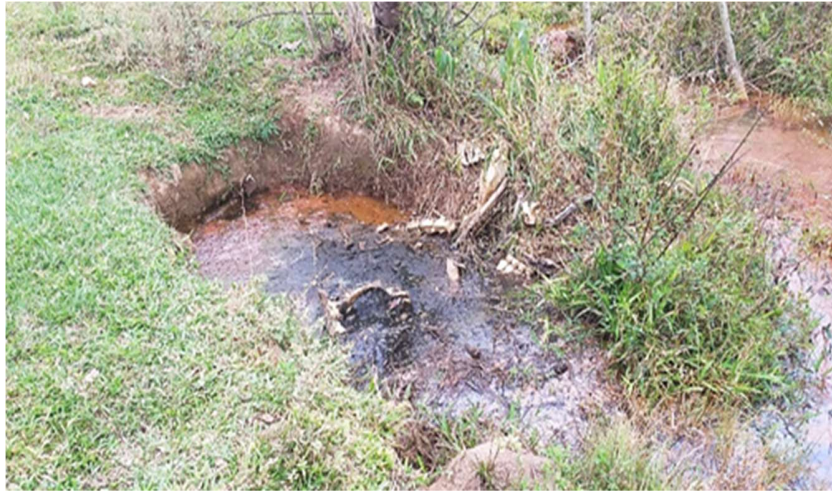
The "odor" parameter was only detected in spring 2, which was caused by the presence of bovine carcasses in the spring, in an advanced degree of decomposition (Figure 6). In rural areas, particularly during the dry season, it is not uncommon for cattle to seek out greener pastures in areas with hydromorphic soils, which, according to Nascimento et al. (2013) have poor drainage and are thus usually flooded, which can lead the animal to get stuck and die. Santos et al. (2015) mention that, in addition to the characteristic odor, water contaminated with corpses can be microbiologically contaminated with heterotrophic and proteolytic bacteria, sulfite-reducing clostridia, enteroviruses and adenoviruses. Additionally, there is usually high oxygen consumption due to biological decomposition and chemical transformations, mainly of products containing nitrogen, phosphorus and sulfur, among others. There is also an increase in the amount of mineral salts, increasing the electrical conductivity of these waters.

*Figure 6 – Presence of bovine carcasses in the water of spring 2.
Source: Prepared by authors (2022).*

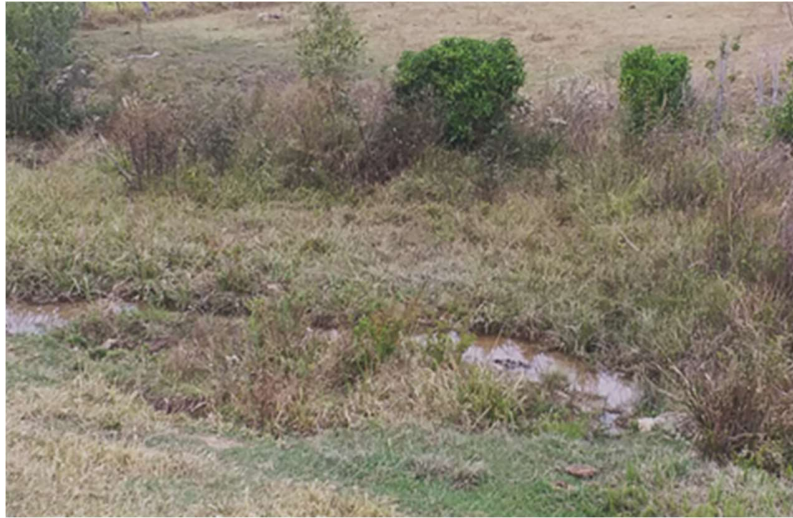
Vegetation in a good conservation state was only found at spring 5; the other springs had their vegetation categorized as "altered" (3, 4, 6, 7, 10 and 13) or "degraded or absent" (1, 2, 8, 9 and 11). It is worth highlighting the record of deforestation in spring 6, with the suppression of large and medium-sized tree species for timber extraction (Figures 7 and 8). According to the New Forest Code (BRASIL, 2012), in the case of springs, a minimum dimension of the marginal strip of native vegetation to be preserved must be considered, regardless of its topographic condition, of at least 50 meters around the springs or 15 meters in rural areas consolidated before July 22, 2008.

*Figure 7 – Degraded or absent vegetation at the spring 1.
Source: Prepared by authors (2022).*

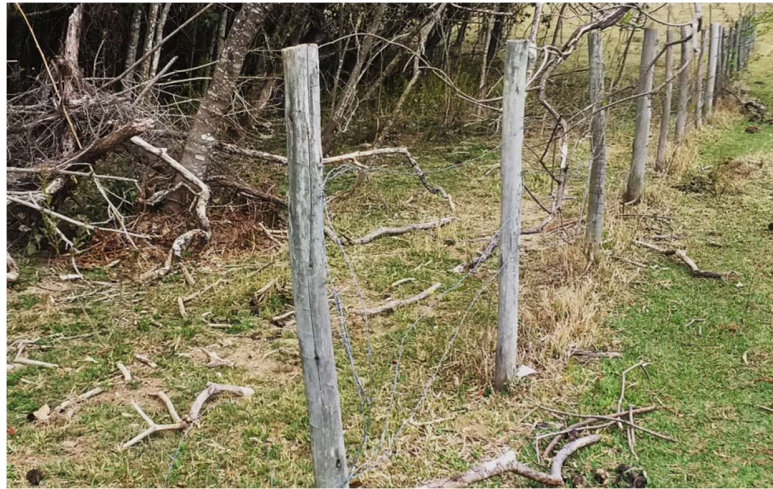
Properly installed and operational fencing was not found at any of the assessed springs (Chart 2, Figures 9 and 10). At spring 8, there was material from an old fence in a poor state of repair, with rotten posts and broken wires, which did not prevent cattle and horses from crossing (Figure 10). According to Pinto et al. (2004) and Fonseca and Gontijo (2021), fencing off spring areas is of major importance, as it delimits the space where they are located and prevents large domestic animals from entering.

*Figure 9 – Fence in a poor state (notice the broken wires) at spring 8.
Source: Prepared by authors (2022).*

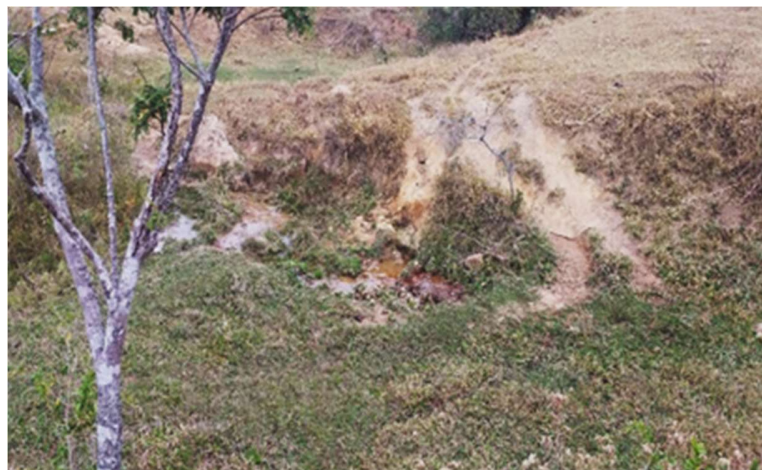
*Figure 10 – Absent fencing at spring 1.
Source: Prepared by authors (2022).*

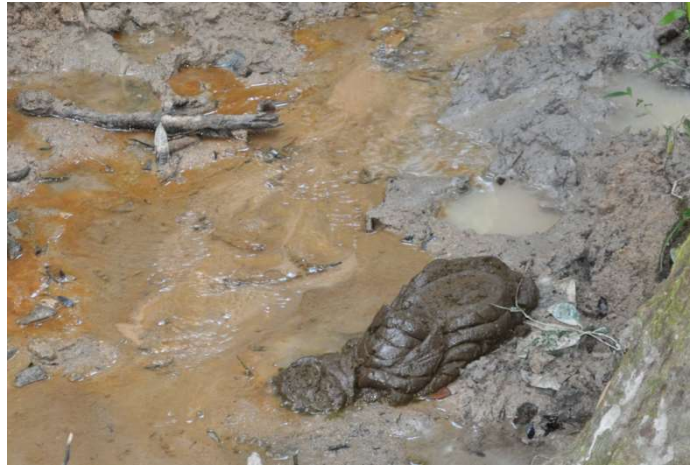
The use of the spring area by large domestic animals (cattle and horses), detected by their presence or marks such as footprints or droppings, was verified in 7 of the 12 springs evaluated (Chart 2, Figures 11 and 12). The presence of these animals in the Permanent Preservation Areas (PPAs) of the springs tends to have a negative impact on the vegetation and also favors soil compaction and revolving, causing silting, erosion and increased water turbidity, as well as microbiological contamination that occurs mainly through feces and urine. (FONSECA e GONTIJO, 2021). CARVALHO et al. (2020) adds that soil compaction caused by trampling reduces the spring's ability to emerge, favoring its drying out.

Figure 11 – Presence of large domestic animal traces (footprints and droppings) in spring 3.
Source: Prepared by authors (2022).
