REVISTA DE GEOCIÊNCIAS DO NORDESTE

v. 11, nº 2 (2025)

Risks of accidents caused by urban drainage infrastructure in Brazilian cities

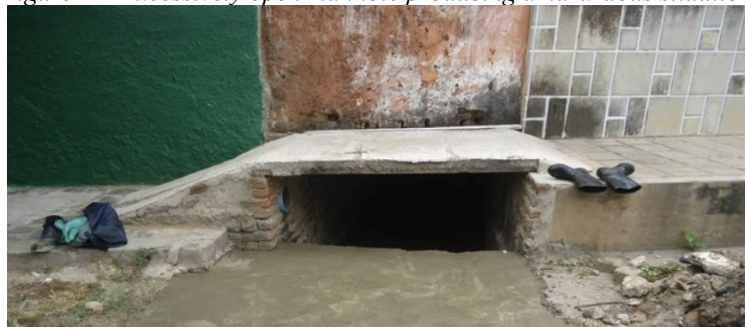
During dry periods, accidents also occur due to negligence in the execution of drainage works or the lack of proper maintenance (Miguez *et al.*, 2015). Figure 1 illustrates a common vulnerability in many Brazilian cities, where the opening of a gutter drain is excessively large, increasing the risk of accidents (TASSI *et al.*, 2016).

Figure 1 – Excessively open manhole producing a hazardous situation.

Canholi (2014) highlights that wide openings in gutter drain can result in pedestrians, cyclists, and even vehicles being swept in or falling under extreme conditions. Melo et al. (2016) further emphasize the need for proper design of these micro-drainage elements in order to minimize accident risks and ensure user safety. Therefore, it is essential to implement technical standards that regulate the sizing of these structures, aiming at accident prevention and public safety.

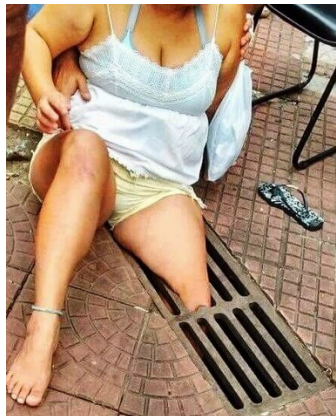
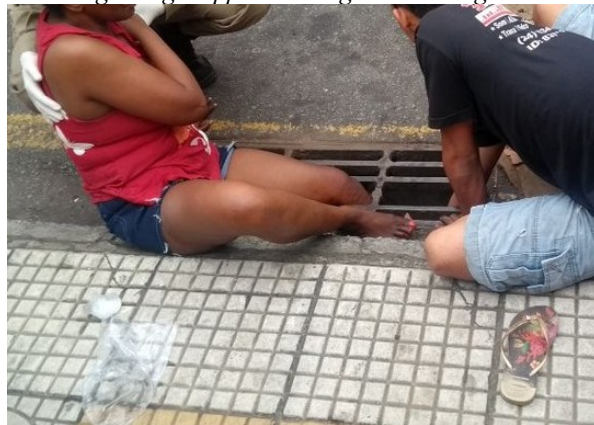
Figures 2 and 3 illustrate incidents that occurred in the cities of São Vicente (SP) and Volta Redonda (RJ), where pedestrians, upon stepping on gutter drain grates with compromised structural integrity, had their legs trapped due to the rupture of one of the bars. Firefighters were required to safely remove the victims. Similar incidents were reported in the municipalities of Olinda (PE), Macapá (AP), Rio de Janeiro (RJ), and Cariacica (ES). Injuries included deep cuts, abrasions, and, in some cases, knee sprains.

Figures 2 and 3 – Accident while walking on the street resulting in leg trapped in the gutter drain grate.

According to Figures 2 and 3, safety issues related to gutter drain grates with compromised structural integrity are concerning and have been discussed in the technical literature (Tassi et al., 2016). Damaged grates can lead to falls, serious injuries, and even fatal accidents (Melo et al., 2016). Studies indicate that inadequate maintenance, the quality of materials used, and exposure to high loads are factors that can affect the durability and strength of the grates (Baptista et al., 2011).

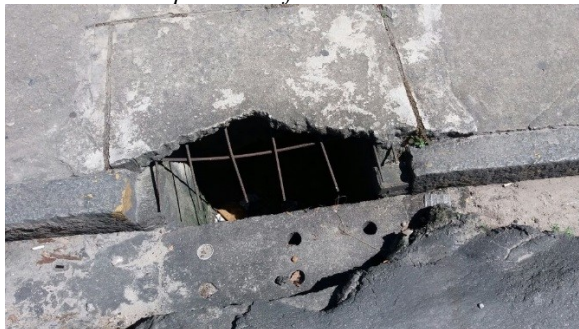
The deterioration of manhole covers, which exposes reinforcement bars and creates a significant risk for pedestrians and cyclists, remains a continuous challenge in public infrastructure management (Figure 4).

Figure 4 – Damaged manhole cover with exposed reinforcement bars: serious risks for pedestrians or cyclists.

Exposed reinforcement bars can cause deep abrasions (Uddin et al., 2013) and illustrate the need for regular maintenance and infrastructure monitoring to prevent incidents (Butler et al., 2018). Sustainable urban drainage systems and green infrastructure can minimize these risks while providing environmental and aesthetic benefits (Hoang and Fenner, 2016).

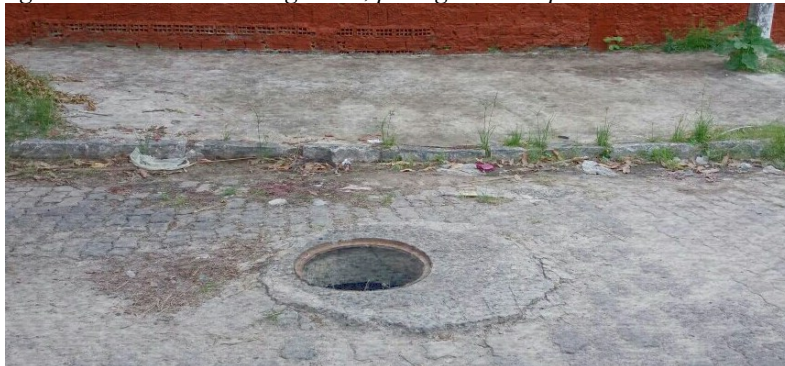
The absence or damage of manhole covers is a recurring problem in many Brazilian cities, whether on roadways or sidewalks (Figure 5). Missing covers can cause serious accidents involving pedestrians. For example, in 2014, a woman suffered spinal injuries and was diagnosed with tetraplegia after falling into a manhole in Arraias (TO). Additionally, six other incidents involving falls into manholes resulting in injuries, although less severe, were reported in São Paulo (SP), Cariacica (ES), João Pessoa (PB), Boa Vista (RR), Vitória (ES), and Bauru (SP) between 2013 and 2017.

Figure 5 – Manhole missing cover, posing a risk to pedestrians or vehicles.

The absence or damage of manhole covers on roadways constitutes a significant traffic hazard, with the potential to cause serious accidents. Vehicles traveling at high speeds encountering such obstacles may lose control, resulting in collisions and crashes (Singh, 2022).

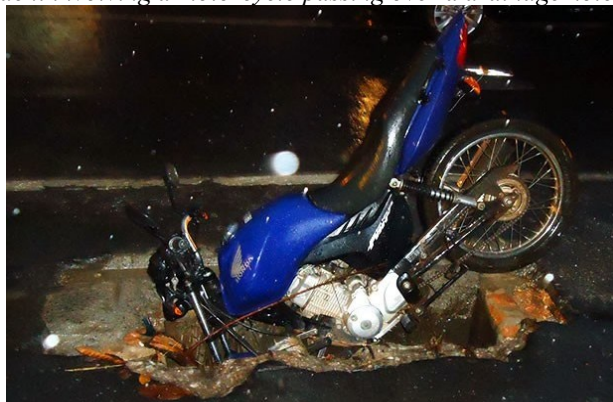
According to Figure 6, the unevenness between the manhole cover and the asphalt poses a significant risk for traffic accidents, especially for motorcyclists. When crossing these uneven surfaces at high speeds, motorcyclists may lose control, resulting in falls and collisions with other vehicles, poles, or trees (Gomes, 2012; Nasri and Aghabayk, 2021). In 2017, two motorcyclists lost their lives in accidents related to uneven manhole covers in Goiânia (GO) and São José do Rio Preto (SP).

Figure 6 – Accident involving a motorcycle passing over a drainage hole without a cover.

In Goiânia, a victim fell after passing over a manhole cover submerged in water with a 6 cm unevenness and was subsequently run over by another motorcyclist. In São José do Rio Preto, a motorcyclist swerved while crossing an uneven manhole cover and collided with a tree.
