Conflicts over the occupation of the area surrounding the Pedro Moura Júnior reservoir in the Ipojuca River watershed

Conflitos pela ocupação do entorno do reservatório Pedro Moura Júnior da bacia do rio Ipojuca

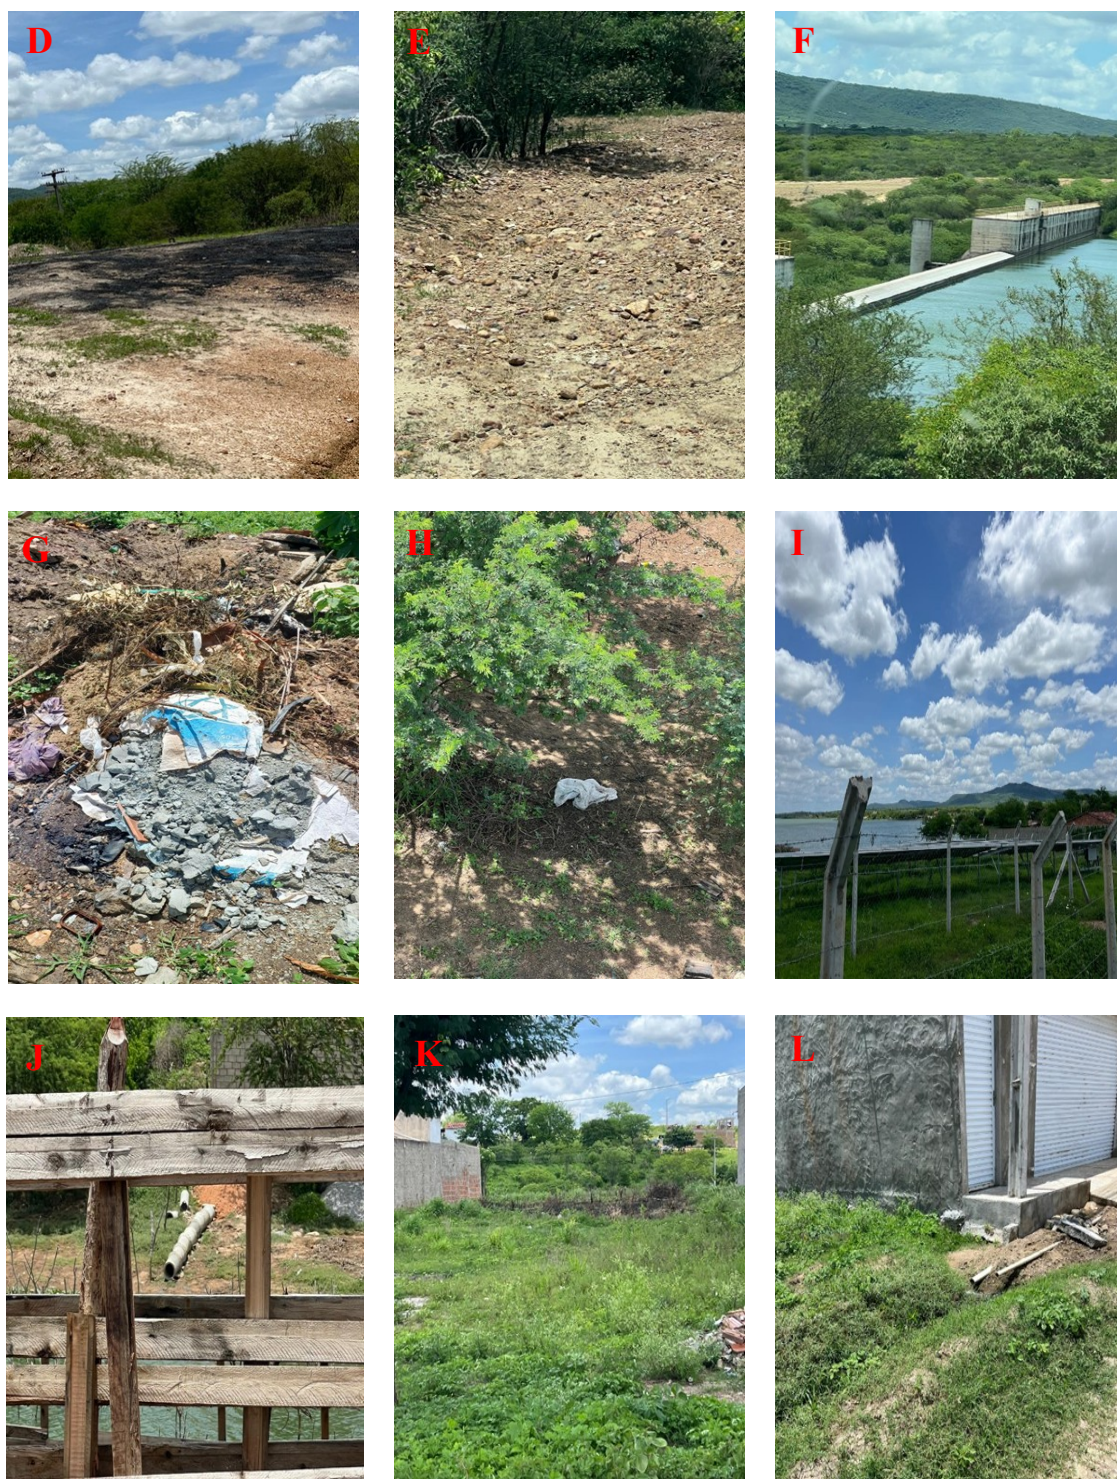
Figura 5 - Land use and land occupation in the area of influence of the Pedro Moura Júnior Reservoir, belonging to the

Ipojuca River watershed, located in Belo Jardim, Pernambuco: left bank compared to upstream (A); residents around the reservoir (B); land occupied by animals (C); soil exposed to burning (D); soil exposed to erosion on the right bank upstream (E); reservoir spillway (F); open-air solid waste (G); plastic bags along the reservoir banks (H); photovoltaic panels (I); exposed pipelines along the reservoir bank (J); excessive plant growth (K); and direct discharge of domestic effluents into the soil (L).

As shown in Figure 5A, the occupation around the Pedro Moura Júnior Reservoir has noticeably increased, particularly on the left bank near the spillway, where there are agricultural crops, recreational areas, animals, and residences. In Figure 5B, it can be observed that the residents gather and manage the agricultural systems collectively, while in Figure 5C, although the animals have designated areas, they can still roam freely around the reservoir. Indeed, the area is difficult to access, and despite the increasing number of residents, it still constitutes a diffuse rural landscape, assuming a role of invisibility, since there is no basic sanitation (sewage, water supply, and wastewater treatment, and solid waste management).

In Figure 5D, taken from the left side near the reservoir spillway, it can be observed that a possible burning of objects occurred, although the origin could not be identified, as only traces of soil exposed to fire are visible in the image. Figure 5E depicts what is most common in this section: soil exposed with stones and signs of local vegetation loss. In Figure 5F, the spillway is shown with only 5 cm remaining until overflow, which is expected to occur in March, at the onset of the rainy season. According to climatological data calculated from a 30-year series, the website Climatempo (2025) indicated that the months of highest precipitation in the municipality are March, April, May, and June.

Figure 5G shows the improper disposal of solid waste in the open, combined with the irregular burning of materials. The image was captured near residences surrounding the reservoir, highlighting environmental and public health risks. Additionally, the presence of a zucchini plantation can be observed, indicating the use of land for agricultural activity in the region. In Figure 5H, an accumulation of plastic bags along the reservoir banks is evident, resulting from deficiencies in the public waste collection service in the community, according to residents' reports.

Regarding Figure 5I, photovoltaic panels installed in the area stand out, presumably intended to supply electricity to nearby residential or recreational zones, considering the urban density in the locality. According to Silva, Drach, and Barbosa (2019), this modality is characterized by electricity generation close to the point of consumption or directly at the consuming establishment. The excess energy produced can be sold to the local utility company.

In Figure 5J, exposed pipes discharging effluents directly into the reservoir banks can be observed, and the image also shows animal containment structures (corrals) made of wood. The discharge of untreated effluents, combined with animal waste that may be carried into the riverbed, directly impacts water quality, as evidenced by the visible change in water coloration. Costa et al. (2021) assessed the influence of anthropogenic activities on water quality in urban lakes, while França (2024) evaluated environmental impacts in the Caiçara stream watershed in Aurora, Brazilian state of Ceará. The aforementioned authors concluded, respectively, that the disposal of untreated effluents and animal excrement compromises water quality.

Figure 5K highlights the excessive growth of macrophytes, associated with nutrient loads from untreated effluents released into the environment. This observation corroborates the study by Santos et al. (2021), which assessed water quality in Pampulha Lagoon (Lagoa da Pampulha), Belo Horizonte, Minas Gerais. The cited authors concluded that raw effluents contain varying concentrations of nutrients; for example, excess phosphorus leads to eutrophication, promoting the uncontrolled growth of algae and aquatic plants. Additionally, fires in adjacent areas have been recorded, further exacerbating environmental degradation.

Regarding Figure 5L, the direct discharge of residential effluents onto the soil is observed, a practice that can lead to contamination of the soil as well as surface and groundwater resources. This situation underscores the urgent need for structural interventions by public authorities, aiming at the universalization of basic sanitation and the mitigation of socio-environmental impacts in the region. The area characterized as urbanized reflects the growth and development of the municipality, although this zone currently overlaps with rural areas due to inadequate services in some locations. In certain sections, riparian areas can be identified, where houses still lack plumbing systems and/or septic tanks, as shown in Figure 6.

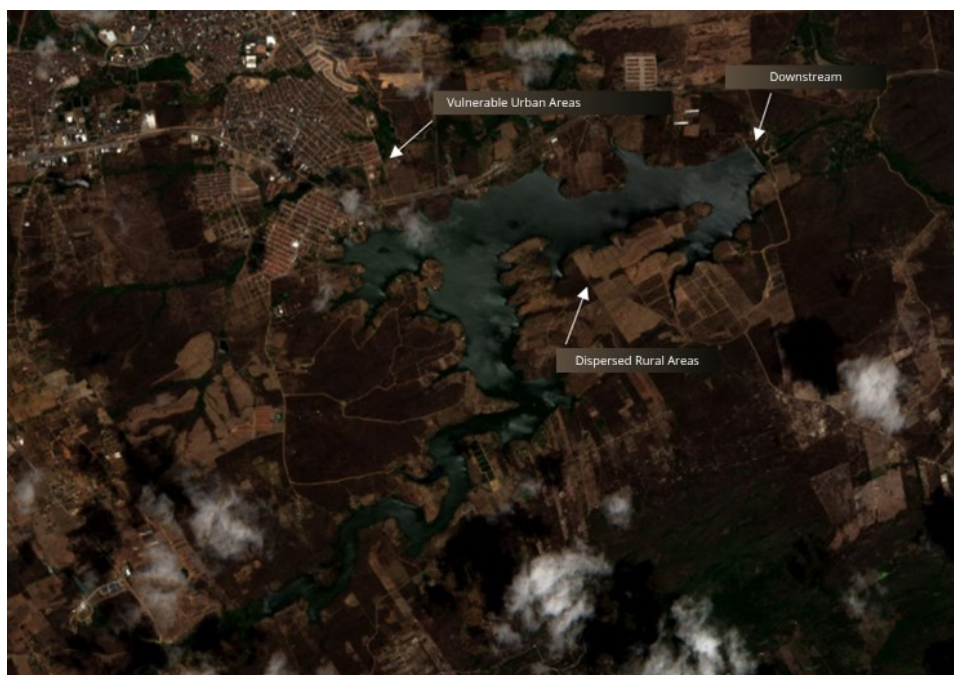
Figura 6 - Delimitation of land use and land occupation in the Pedro Moura Júnior Reservoir, part of the Ipojuca River watershed, located in Belo Jardim, Pernambuco. Sentinel-2A satellite image, acquired through the Copernicus BROWSER platform, with RGB composition performed in QGIS.

Furthermore, there is an extensive rural area with scattered residences, few of which are connected to a sewage system. As in the Ipojuca River watershed, studies indicate challenges related to water quality, including a high potential for soil salinization when water is used for irrigation (ROSA *et al.*, 2024). Therefore, effective management is essential to ensure the sustainability of the reservoir's multiple uses and the environmental preservation of the region.
