## Comparative analysis of crack information extraction using structured light and SfM techniques

Iane Silva Pereira<sup>1</sup>; Samir de Souza Oliveira Alves<sup>2</sup>; Luis Augusto Koenig Veiga<sup>3</sup>

**Abstract:** Structural safety is a critical concern in civil engineering, making the monitoring of pathological manifestations essential, particularly cracks, which are among the most frequent defects in concrete structures. Accurate crack characterization is fundamental to ensuring structural integrity and preventing potential failures. Traditional assessment methods often rely on destructive testing or visual inspection, which may either damage the structure or depend heavily on operator expertise. In contrast, non-destructive techniques enable more reliable and repeatable data acquisition. This study presents a comparative analysis of crack characterization using structured light and Structure from Motion (SfM) techniques. Both approaches generate point clouds from which geometric features, such as crack width, can be extracted. The case study was conducted on a crack located at the Botanic University Restaurant in Curitiba, Paraná, Brazil. Data acquisition was perfor

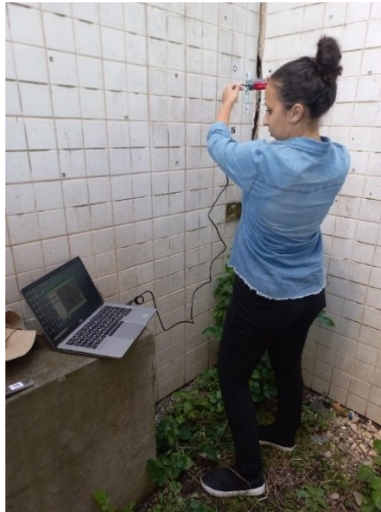
The initial step consisted of connecting the scanner to a notebook to start the data acquisition process (Figure 2). The device offers four scanning modes: object ( $600 \times 600 \times 300$  mm), head ( $800 \times 500 \times 800$  mm), body ( $1000 \times 1000 \times 2000$  mm), and face (approximately the size of a human face).

*Figure 2 – Structured light scanning of the crack.  
Source: The authors (2026).*

After preliminary tests, the head mode was selected as the most suitable for capturing the crack geometry. To minimize signal loss and ensure data quality, the scanner was moved uniformly along the surface, avoiding abrupt movements and oscillations. The scanning process lasted approximately 5 minutes.

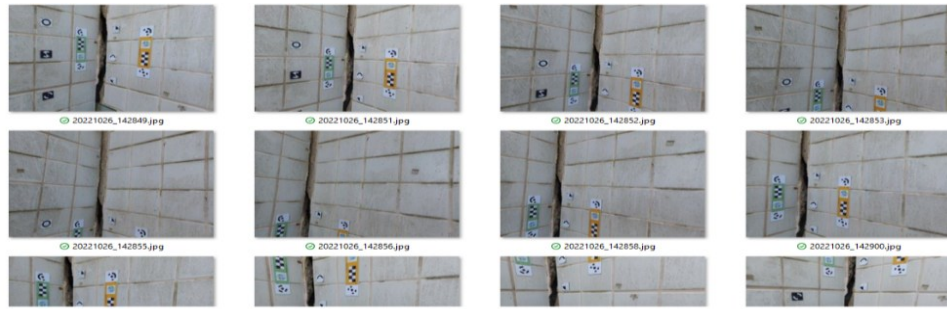
For the SfM method, a Samsung Galaxy A32 smartphone was used, featuring a main camera with a resolution of 64 MP, image resolution of  $9000 \times 7000$  pixels, and a sensor size of approximately  $1/4.0''$ . The device was moved around the crack and the reference targets, capturing a series of images from different angles while maintaining stability to ensure image sharpness.

The images were acquired with sufficient overlap, ensuring that each photograph covered part of the previously captured area. This approach is essential to facilitate accurate feature matching and reliable 3D reconstruction. After a visual inspection, a total of 53 images were selected (Figure 4), based on criteria such as image quality, sharpness, adequate exposure, sufficient overlap, and any blurred or poorly exposed photographs that could compromise the reconstruction process. The selected images were then transferred to a computer for processing.

*Figure 4 – Image acquisition for the SfM method.  
Source: The authors (2026).*

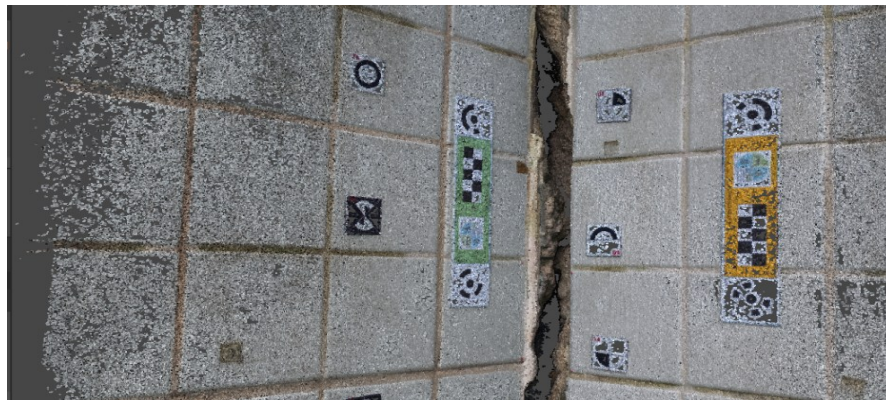
The first processing step consisted of image alignment. In this stage, the software automatically detected and matched homologous features (tie points) between overlapping images using feature detection algorithms. Based on these correspondences, a bundle adjustment was performed to simultaneously estimate the internal camera parameters and their spatial positions and orientations. This step resulted in a sparse point cloud representing the general geometry of the scene. Subsequently, a quality assessment of the alignment was conducted by analyzing the reprojection error and the spatial distribution of tie points. When necessary, poorly matched points were removed to improve the robustness of the solution. After alignment refinement, the dense point cloud was generated using a multi-view stereo (MVS) algorithm. This step significantly increased the number of points, allowing for a more detailed representation of the crack geometry. The quality settings were configured to balance processing time and level of detail. Following the generation of the dense point cloud (Figure 5), a three-dimensional mesh was created to represent surface geometry. The mesh was then used as a basis for texture mapping, in which the original images were projected onto the model to produce a realistic representation of the surface.

*Figure 5 – Dense point cloud generated in Agisoft Metashape.  
Source: The authors (2026).*

To ensure metric consistency, the calibrated targets positioned near the crack were identified and manually marked in the images within the software. These targets were used as control points to define the scale of the reconstructed model. The reference distances adopted in this process correspond to the values obtained from the total station measurements of the graduated measuring devices. Specifically, the distances between the centers of the circular targets (A–B and C–D), were introduced into the software to accurately scale and adjust the model. This procedure ensured that the generated point cloud was metrically consistent with the real dimensions of the structure, reducing scaling errors, and improving the reliability of the geometric measurements extracted from the SfM reconstruction.

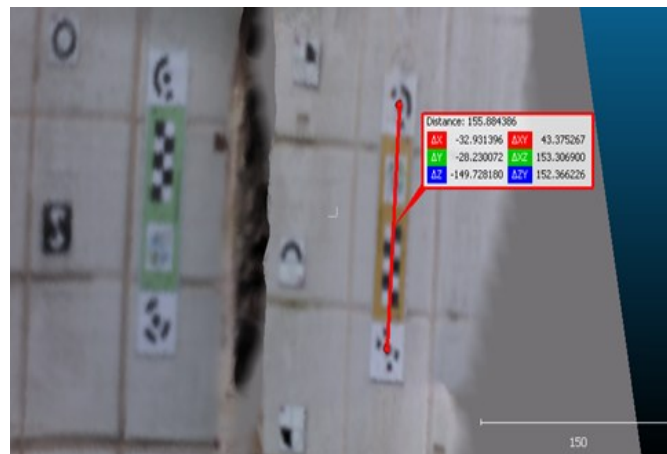
To evaluate the accuracy of the structured light method, the distances between the same reference points (1–2, 3–4, 5–6, and 7–8) were measured using the generated point cloud. The PLY file was imported into CloudCompare, where the “Point Picking” tool was used to select the centers of the circular targets and automatically compute the distances (Figure 7).

*Figure 7 – Crack and measuring devices.  
Source: The authors (2026).*

The distances extracted from the structured light point cloud (Table 2) show a consistent overestimation when compared to the reference values. For the segments A–B and C–D, deviations of approximately +0.57 cm and +0.66 cm were observed, respectively. Similarly, for the longer segments (D–A and C–B), differences of about +0.43 cm and +0.55 cm were identified. The computed mean error (bias) was +0.55 cm, indicating a systematic deviation.
