REVISTA DE GEOCIÊNCIAS DO NORDESTE

v. 8, nº 1 (2022)

A review of accidents in mining tailing dams in South America and the Brazilian scenario

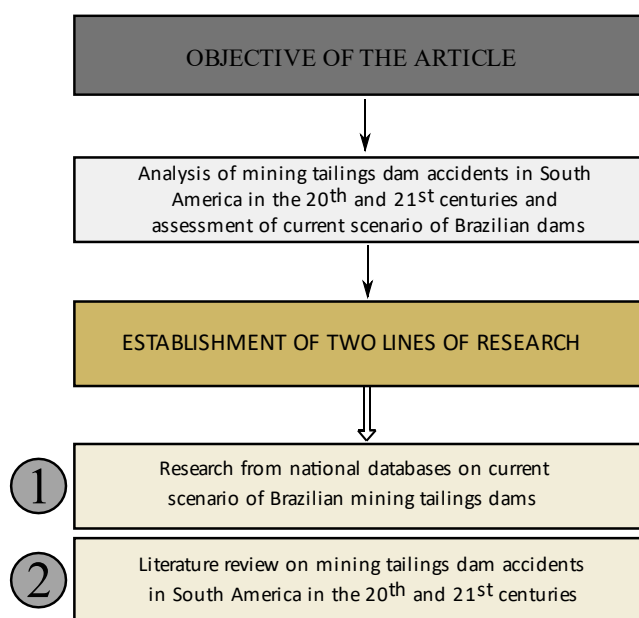
Figure 1 - Methodological procedure for the article.
 Source: Own elaboration (2021)

The methodological procedure used in this article is shown in Figure 1. Considering the objective of the work, research was carried out in two aspects: one related to the knowledge of the current scenario of Brazilian tailings in operation and another related to accidents that occurred in the 20th and 21st centuries in the tailings dams in South America.

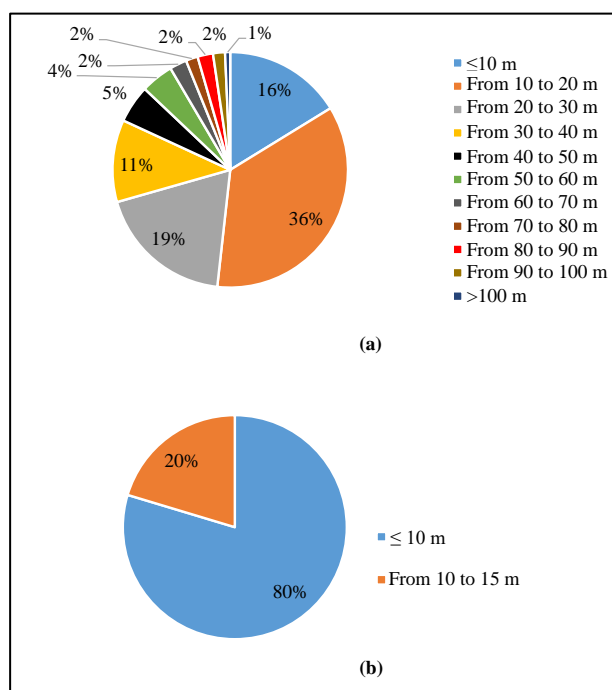
Figure 3 - Dam height distribution a) included in the PNSB; b) not included in the PNSB
 Fonte: Own elaboration (2021).

Figure 3 shows the height distribution of tailings dams in Brazil. Among the dams inserted in the PNSB, most (36%) are between 10 and 20 m high, while only 1% are higher than 100 m (Figure 3a). On the other hand, in Figure 3b, it can be seen that, for dams not included in the PNSB, 80% are less than 10 m high, while 20% are between 10 and 15 m high.

It can be observed that the dams in the PNSB have a height and volume greater than those not included. This is expected and is due to the fact that Brazilian legislation makes the classification of larger dams mandatory (height above 15 m and volume above 3 million m³) to be included in the PNSB.

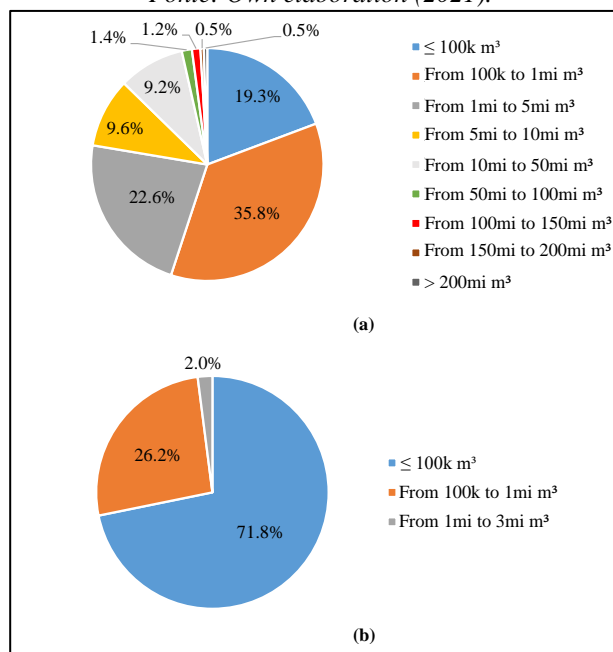
Figure 1 - Distribution of storage volumes of dams a) included in the PNSB; b) not included in the PNSB
 Fonte: Own elaboration (2021).

Regarding the stored tailings volumes, Figure 4a shows the volume distribution for the dams inserted in the PNSB. It is observed that most dams (35.8%) store between 100 thousand and 1 million m³ of tailings. For dams not included in the PNSB (Figure 4b), it can be seen that the majority (71.8%) store less than 100,000 m³ of tailings and the largest storage does not exceed the range of 3 million m³.

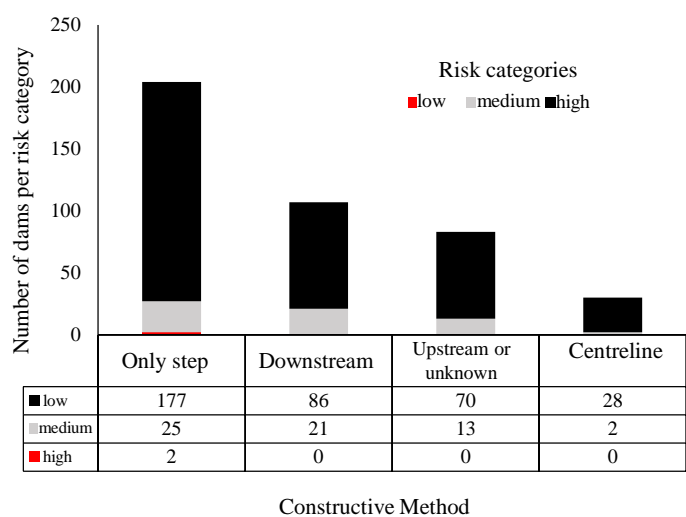
Figure 9 - Risk categories of dams depending on the construction method
 Fonte: Own elaboration (2021).

Figure 9 shows the risk categories of tailings dams as a function of the construction method used. It is confirmed that most dams are in a low risk situation. Only two dams were identified in a high risk category and both were built in a single stage. It can be observed that, among the dams built by single stage, 27 (about 13%) have a medium and high risk category, so about 87% of the dams built by a single stage have a low risk category. For dams executed by raising downstream, 21 (about 20%) fall into the medium risk category and the remaining 80%, into the low risk category. Regarding upstream dams, 13 (about 16%) are in the medium risk category, thus 84% of upstream dams are in the low risk category. Finally, it is observed that all dams executed by centerline, only 2 (about 7%) are in the medium risk category, therefore 93% of dams executed by centerline are in the low risk category.

It is important to highlight that the risk category of a dam, according to the National Dam Safety Policy, does not only depend on the executive method of the structure, but is also a function of the technical characteristics, state of conservation and age of the project, as well as other criteria defined by the supervisory body. Therefore, although, in general, dams built using the upstream raising method are more susceptible to accidents, the results show that this was not the crucial factor that determined the definition of the dam risk category.

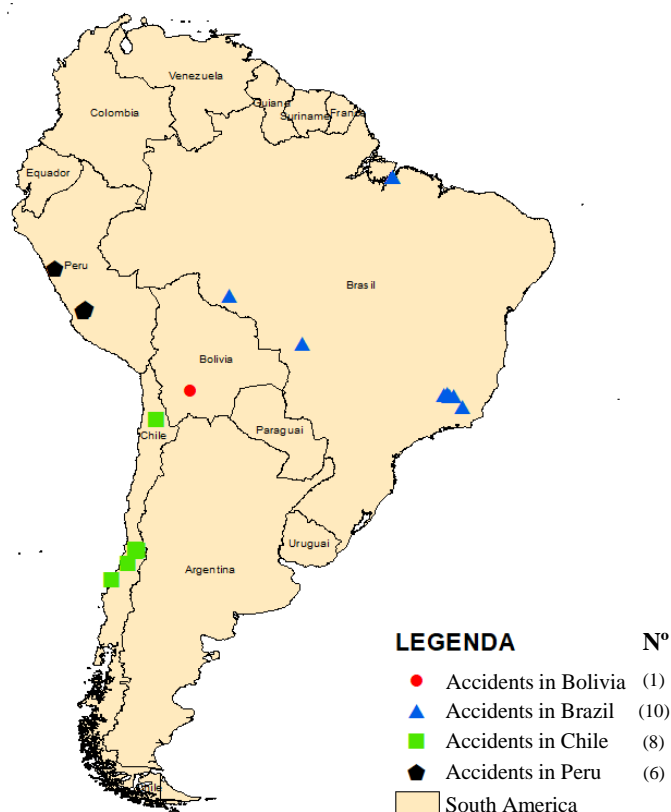
Figure 3 - Location map of accidents in tailings dams in South America in the 20th and 21st centuries
 Fonte: Own elaboration (2021).

In the literature, 25 tailings dams accidents in South America occurred in the 20th and 21st centuries were found. Table 2 presents the cases, with the location of the dams, height, type of ore, construction method and the causes of the failures that occurred. Figure 10 shows the location of accidents, which occurred in Brazil, Peru, Chile and Bolivia.

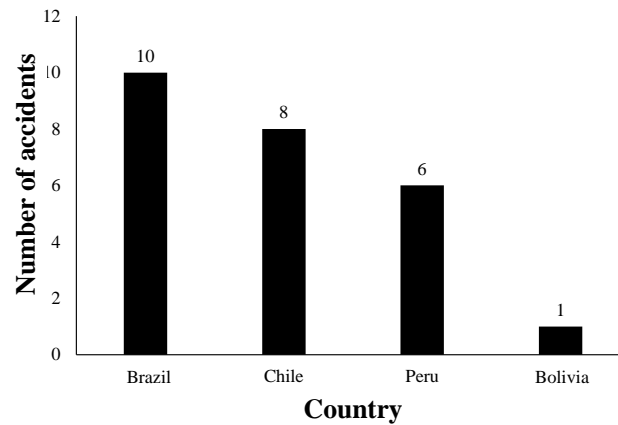
Figure 5 - Number of accidents in tailings dams by country
Fonte: Own elaboration (2021).

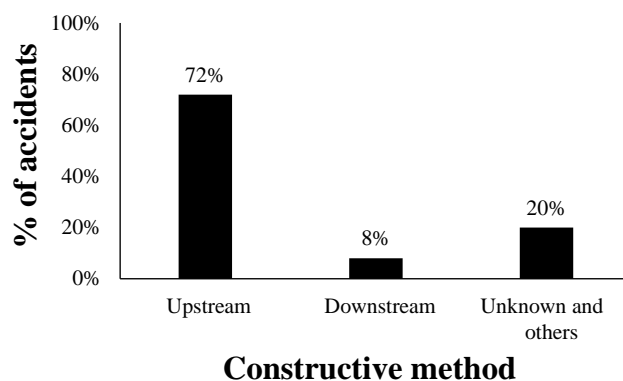
Figure 8 - Percentage number of accidents in tailings dams due to the construction method.
 Fonte: Own elaboration (2021).

Figure 15 shows the percentage number of accidents in tailings dams as a function of the construction method. It can be observed that 72% of the dams that failed had the constructive upstream raising method, which goes against what was observed by Lyu et al. (2019). This showed that almost 60% of the dams that suffered accidents in the world in the 20th and 21st centuries had this construction method. This confirms what the technical literature establishes about the upstream raising method, which, despite leading to more savings, is more susceptible to instability

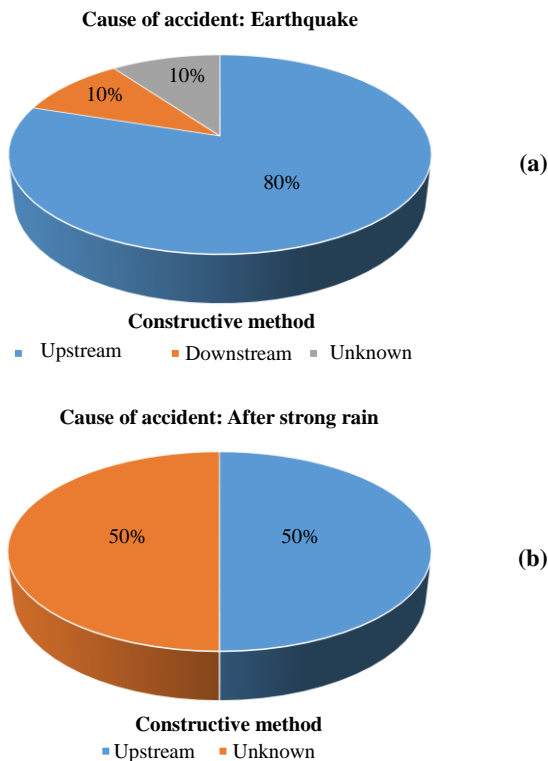
Figure 9 - Relation between the construction method of tailings dams and the causes of accidents due to: (a) Earthquake; (b) After heavy rains
 Fonte: Own elaboration (2021).

When analyzing the main causes of accidents in tailings dams in South America (earthquakes and heavy rains), Figure 16(a) shows that among all dams that suffered accidents due to earthquakes, 80% had an upstream raising method. This finding corroborates the studies in the literature, which point to the high risk of instability of upstream dams considering seismic actions. It is because of this situation that seismic countries, such as Chile and Peru, prohibit the upstream raising method. The Chilean government's Final Report V.4 (2018) highlights that Chile and Peru, as they are countries with active seismicity, do not implement the upstream raising method, as they represent a high risk of collapse and informs that almost all accidents and failures of tailings dams occurred in the world were in structures built by the upstream method.

Concerning Figure 16(b), it can be observed that among the dams that collapsed after heavy rains, which occurred mainly in Brazil, 50% were built using the upstream raising method. This demonstrates once again the high vulnerability of this type of dam to unstable natural events.

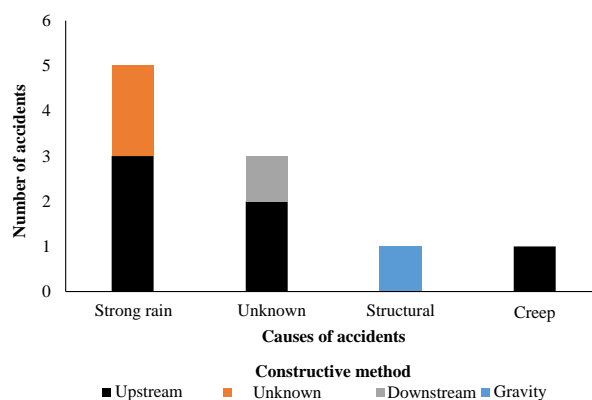
Figure 10 - Relationship between the causes of accidents in tailings dams in Brazil and their construction method
 Fonte: Own elaboration (2021).

Dealing specifically with accidents that occurred in Brazil, Figure 17 shows the relationship between the causes of accidents and the construction methods used in dams. The main cause of accidents in tailings dams in Brazil is related to the occurrence of heavy rains, with 5 cases, 3 of which in dams built using the upstream method. The Chilean government's study (Final Report V.4, 2018), highlights that while Chile and Peru observe more seismic risks, in Brazil the special concern is related to the implementation of drainage systems to prevent flooding, in addition to measures to prevent water erosion from dams.

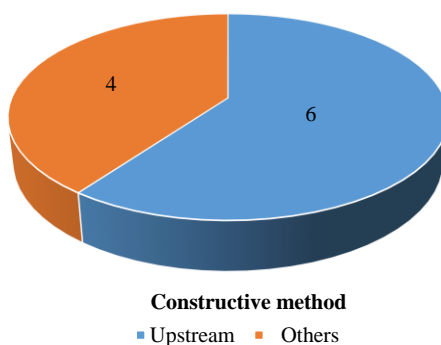
Figure 11 - Number of accidents in tailings dams in Brazil due to the construction method
 Fonte: Own elaboration (2021).

Figure 18 summarizes that among the 10 accidents found in Brazilian tailings dams in the 20th and 21st centuries, six occurred in dams built by the upstream method, attesting once again to the high risk of this type of construction, corroborating what establishes the literature. This situation shows the need for stricter national legislation regarding the raising upstream method. Infact, recent accidents in upstream dams in Mariana (2015) and Brumadinho (2019) have prompted an update on the National Dam Safety Policy in Brazil. The institution of law 14066/2020 prohibits the construction or upstream raising method in Brazil. This situation represents an advance that was necessary in the national regulation, as shown by the data obtained in this work
